## Product Change Notification - SYST-03GEE0632

**Notification subject:** ERRATA - dsPIC33EPXXX(GP/MC/MU)806/810/814 and PIC24EPXXX(GP/GU)810/814 Errata Errata Document Revision

## dsPIC33EPXXX(GP/MC/MU)806/810/814 and PIC24EPXXX(GP/GU)810/814 Family Silicon Errata and Data Sheet Clarification

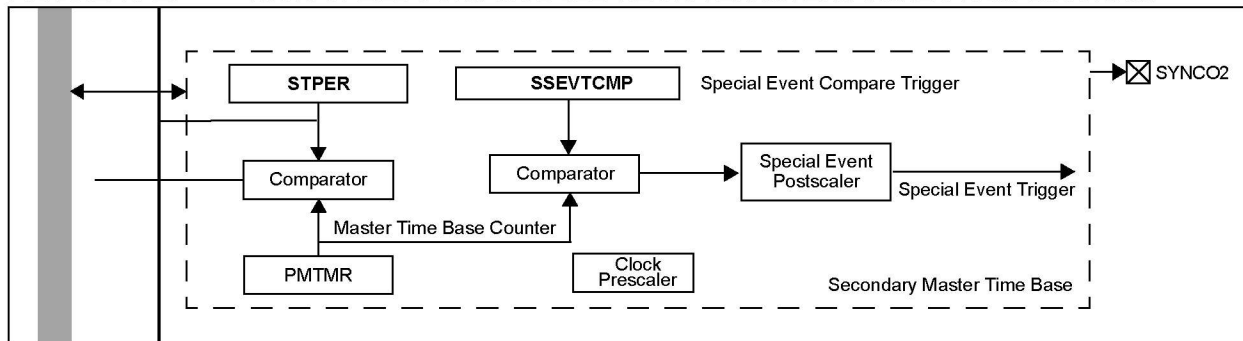
**FIGURE 16-2: HIGH-SPEED PWM MODULE REGISTER INTERCONNECTION DIAGRAM**

In **Figure 16-2: High-Speed PWM Module Register Interconnection Diagram**, the Secondary Master Time Base section has been updated. The updated text is shown in **bold** in [Figure 16-2](#) below.
