Product Change Notification - SYST-07CTIP051

Notification subject: ERRATA - LAN951x FamilySilicon Errata and Data Sheet Clarification Errata Document Revision

LAN951x Family Silicon Errata and Data Sheet Clarification

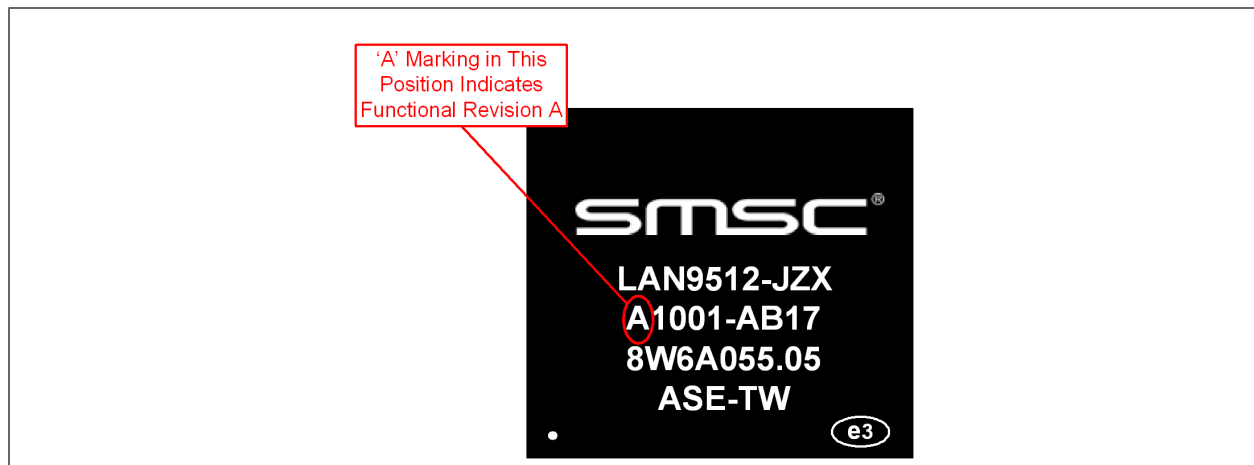
FIGURE 1: TOP MARKING FOR FUNCTIONAL REVISION A DEVICE

This document describes known anomalies for functional revisions A and B of the LAN951x family of devices (LAN9512i/ LAN9512j, LAN9513/ LAN9513i, and LAN9514/ LAN9514i). The functional revision can be determined by its top marking as indicated in Figure 1 and Figure 2.
