Product Change Notification - SYST-11YPLB717

Notification subject: ERRATA - LAN8740A/LAN8740Ai - Silicon Errata and Data Sheet Clarification Errata Document Revision

LAN8740A/LAN8740Ai Silicon Errata and Data Sheet Clarification

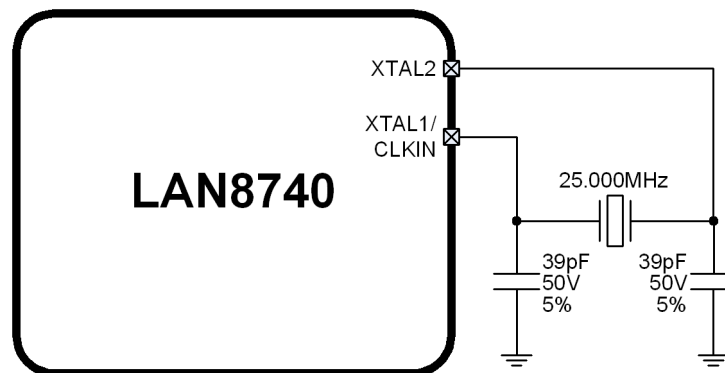
FIGURE 3: EXAMPLE EXTERNAL CRYSTAL CIRCUIT

In EEE mode, the device may drop link when using a Broadcom BCM53125 link partner at cable lengths less than 20 meters.

When using a Broadcom BCM53125 link partner in EEE mode, the device may drop link when using cable lengths less than 20 meters. The BCM53125 has exhibited a sensitivity to minute deviations in its link partner's transmit clock frequency during 100Mb EEE operation. This issue is exacerbated at short cable lengths. This anomaly does not impact 10Mb or non-EEE operation.

1. Utilize an Ethernet cable length of greater than 20m.
2. Increase the load capacitors on the LAN8740A/LAN8740Ai external crystal circuit to 39pF and exercise best practices for board layout. Refer to [FIGURE 3](#): for an example external crystal circuit.

3. Use a single-ended 25MHz clock source that meets the LAN8740A/LAN8740Ai specification requirements in lieu of a crystal.
