# Product Change Notification - SYST-11NVEM452

**Notification subject:** ERRATA - LAN8741A/LAN8741Ai - Silicon Errata and Data Sheet Clarification Errata Document Revision

## LAN8741A/LAN8741Ai Silicon Errata and Data Sheet Clarification

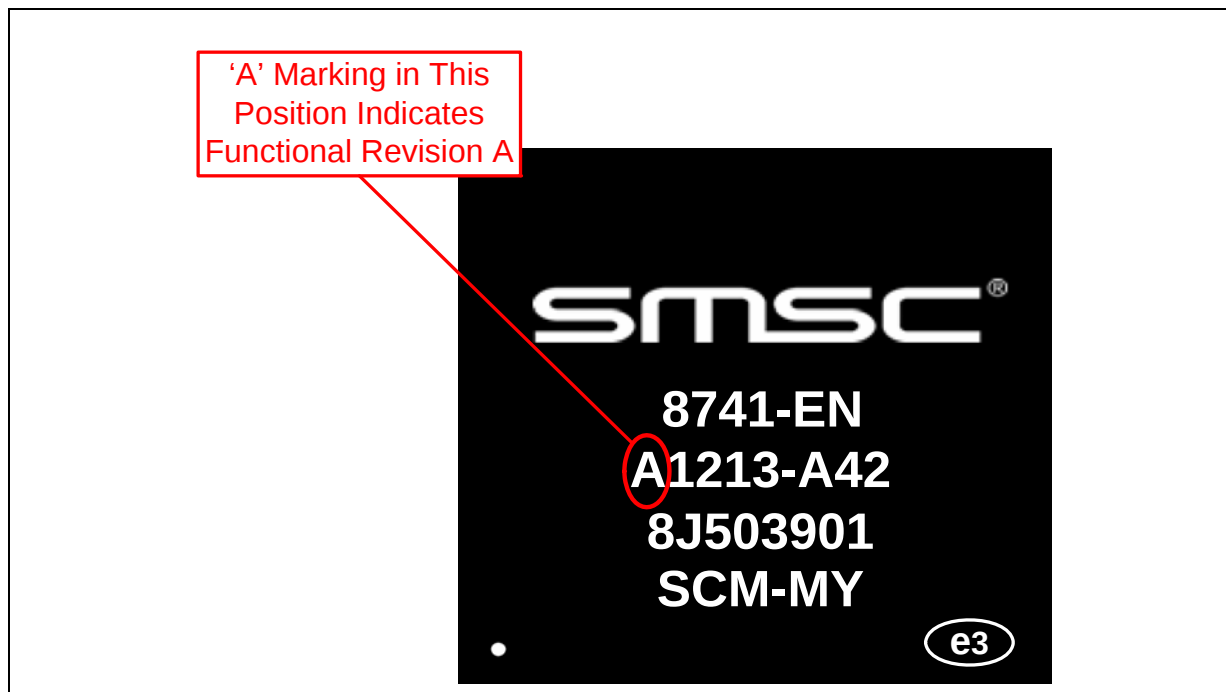
FIGURE 1: TOP MARKING FOR FUNCTIONAL REVISION A DEVICE

**Note:** Figure 1 and Figure 2 detail the top markings of example parts. Other than the highlighted revision marking, other top marking values may differ (manufacture date, lot codes, industrial temperature part, etc.)

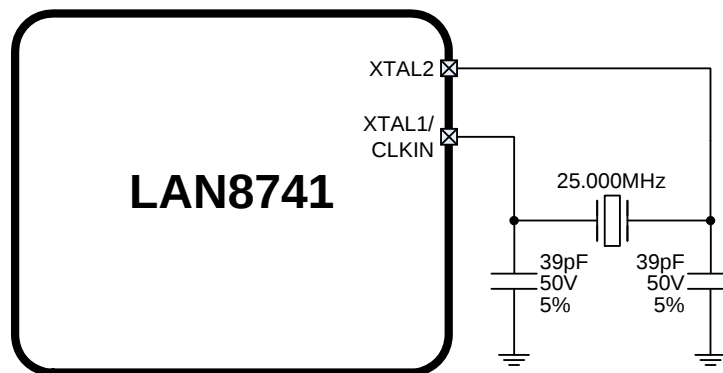
**FIGURE 3: EXAMPLE EXTERNAL CRYSTAL CIRCUIT**

In EEE mode, the device may drop link when using a Broadcom BCM53125 link partner at cable lengths less than 20 meters.

When using a Broadcom BCM53125 link partner in EEE mode, the device may drop link when using cable lengths less than 20 meters. The BCM53125 has exhibited a sensitivity to minute deviations in its link partner's transmit clock frequency during 100Mb EEE operation. This issue is exacerbated at short cable lengths. This anomaly does not impact 10Mb or non-EEE operation.

1. Utilize an Ethernet cable length of greater than 20m.
2. Increase the load capacitors on the LAN8741A/LAN8741Ai external crystal circuit to 39pF and exercise best practices for board layout. Refer to [FIGURE 3](#): for an example external crystal circuit.

3. Use a single-ended 25MHz clock source that meets the LAN8741A/LAN8741Ai specification requirements in lieu of a crystal.
