Product Change Notification - SYST-15YXLG147

Notification subject: ERRATA - KSZ9477S Silicon Errata & Data Sheet Clarification Errata Document Revision
Notification text: SYST-15YXLG147

KSZ9477S Silicon Errata and Data Sheet Clarification

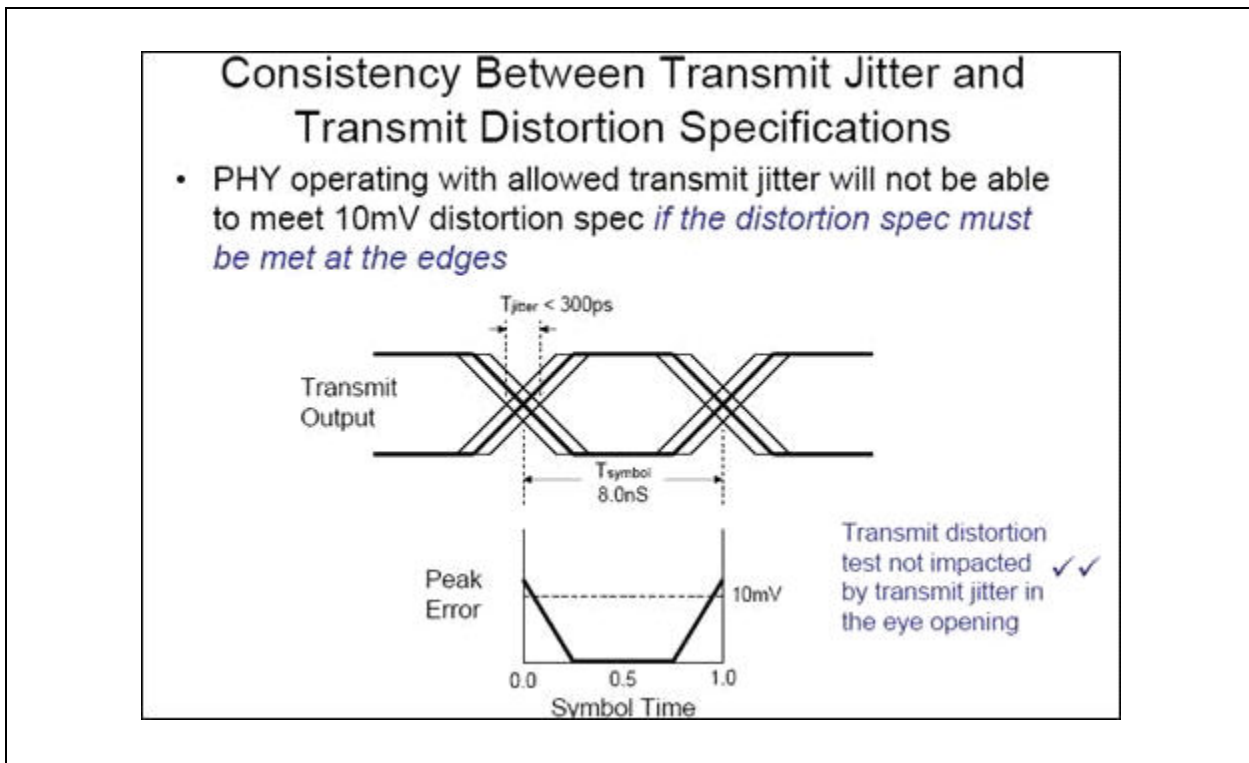
FIGURE 1: IEEE DOCUMENT PAGE 6

The device's 1000BASE-T Transmitter Distortion is approximately 40mV, versus the <10mV indicated in the IEEE specification.

IEEE testing calls for <10mV peak transmitter distortion for at least 60% of the UI within the eye opening. However, this measurement might not be valid, as the transmit distortion test is sensitive to transmit jitter. Refer to the explanation below, taken from the aforementioned IEEE document.

- On page 6, a contradiction between Transmit Jitter and Transmit Distortion requirements:
