# Product Change Notification - SYST-24TQNM777

**Notification subject:** ERRATA - dsPIC33EPXXX(GP/MC/MU)806/810/814 and PIC24EPXXX(GP/GU)810/814 Errata Errata Document Revision  
**Notification text:** SYST-24TQNM777

## dsPIC33EPXXX(GP/MC/MU)806/810/814 and PIC24EPXXX(GP/GU)810/814 Family Silicon Errata and Data Sheet Clarification

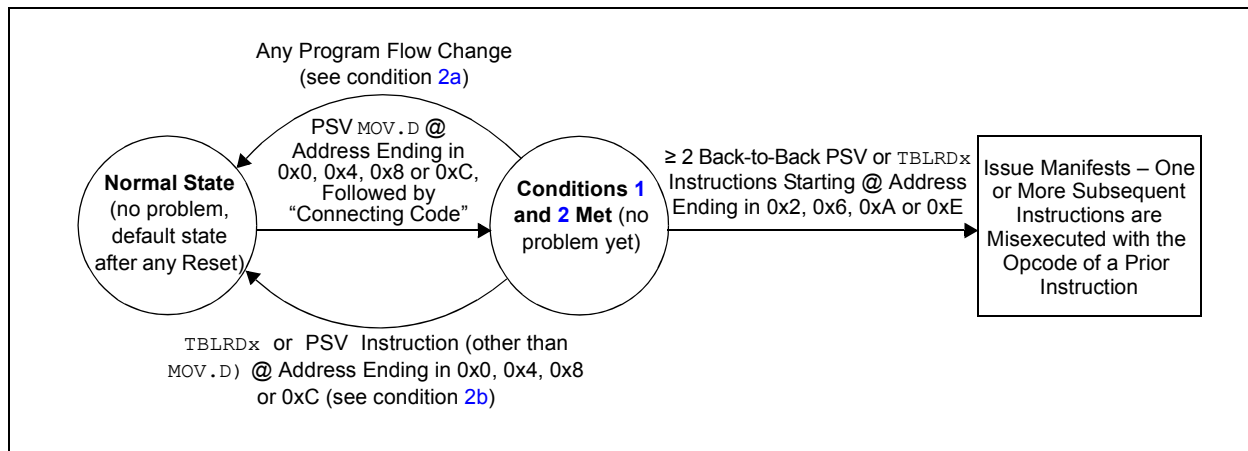
**FIGURE 1: SIMPLIFIED BEHAVIOR**

When two or more data Flash read instructions (via Program Space Visibility (PSV) read or table read) are executed back-to-back, one or more subsequent instructions can be misexecuted when all of the conditions in Table 3 occur.

1.	A PSV MOV.D instruction is executed, with opcode at address ending in 0x0, 0x4, 0x8 or 0xC; and
2.	Some “connecting code” is executed (following the MOV.D of condition 1), with the properties: <ul style="list-style-type: none"> <li>a) The connecting code does not include any program flow changes, including: taken branch instructions (including all versions of BRA, CPBEQ, CPBGT, CPBLT, CPBNE), CALL, CALL.L, GOTO, GOTO.L, RCALL, RETLW, RETURN, vectoring to an ISR, returning from an interrupt (RETFIE) and certain debug operations, such as break and one-step; and</li> <li>b) The connecting code does not include a TBLRDx or non-MOV.D PSV instruction, located at a Flash memory address ending in 0x0, 0x4, 0x8 or 0xC; and</li> <li>c) The connecting code is at least two instruction words in length; and</li> <li>d) The connecting code does not end with a REPEAT instruction, with count &gt; 0; and</li> </ul>

3.	≥ 2 back-to-back PSV or TBLRDx instructions are executed (following the code of condition 2), where the first of the back-to-back instructions is located at an address ending in 0x2, 0x6, 0xA or 0xE.

Figure 1 provides an example of the effective behavior.

The issue can be avoided by ensuring any one or more of the requirements are not met. For example:

1. All instances of PSV `MOV.D` can be replaced with two PSV `MOV` instructions instead. Non-PSV `MOV.D` instructions acting on RAM/SFRs do not need to be modified; or
2. If not already present, a program flow change instruction (such as `BRA $+2`) can be inserted above back-to-back data Flash read sequences; or
3. Back-to-back data Flash read instruction sequences can be broken up by inserting a non-Flash read instruction (such as a `NOB`) in between the Flash read instructions; or
4. The alignment of the code can be shifted to avoid the required opcode location addresses.

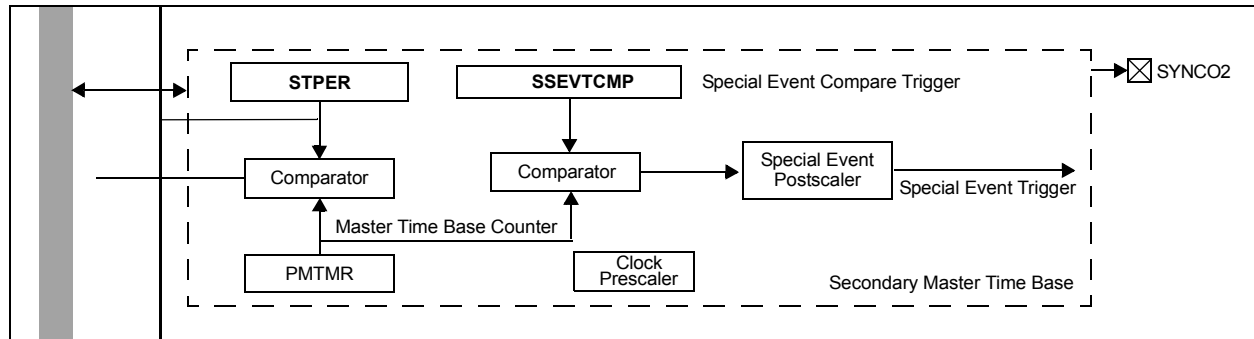
**FIGURE 16-2: HIGH-SPEED PWM MODULE REGISTER INTERCONNECTION DIAGRAM**

In **Figure 16-2: High-Speed PWM Module Register Interconnection Diagram**, the Secondary Master Time Base section has been updated. The updated text is shown in **bold** in [Figure 16-2](#) below.
