# Product Change Notification - SYST-15GZZV803

**Notification subject:** ERRATA - KSZ9896C Silicon Errata & Data Sheet Clarification Errata Document Revision  
**Notification text:** SYST-15GZZV803

## KSZ9896C Silicon Errata and Data Sheet Clarification

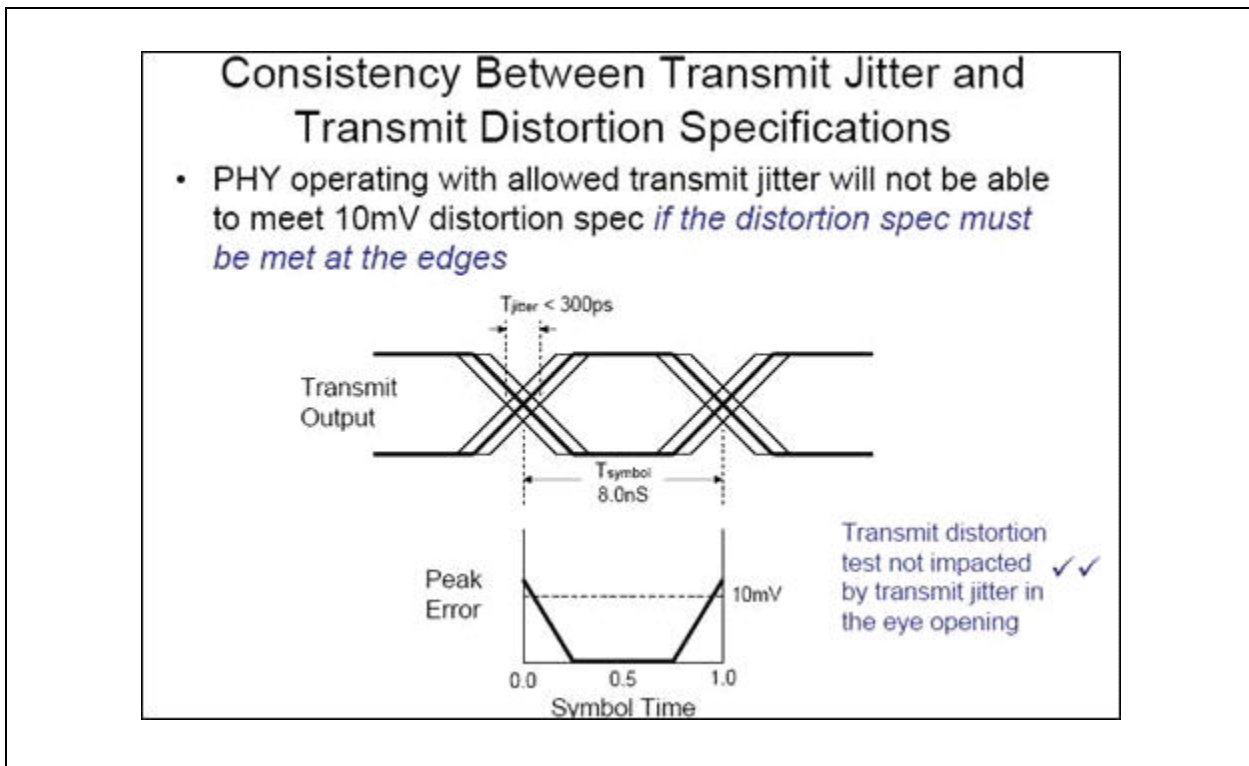
**FIGURE 1: IEEE DOCUMENT PAGE 6**

The device's 1000BASE-T Transmitter Distortion is approximately 40mV, versus the <10mV indicated in the IEEE specification.

IEEE testing calls for <10mV peak transmitter distortion for at least 60% of the UI within the eye opening. However, this measurement might not be valid, as the transmit distortion test is sensitive to transmit jitter. Refer to the explanation below, taken from the aforementioned IEEE document.

- On page 6, a contradiction between Transmit Jitter and Transmit Distortion requirements:

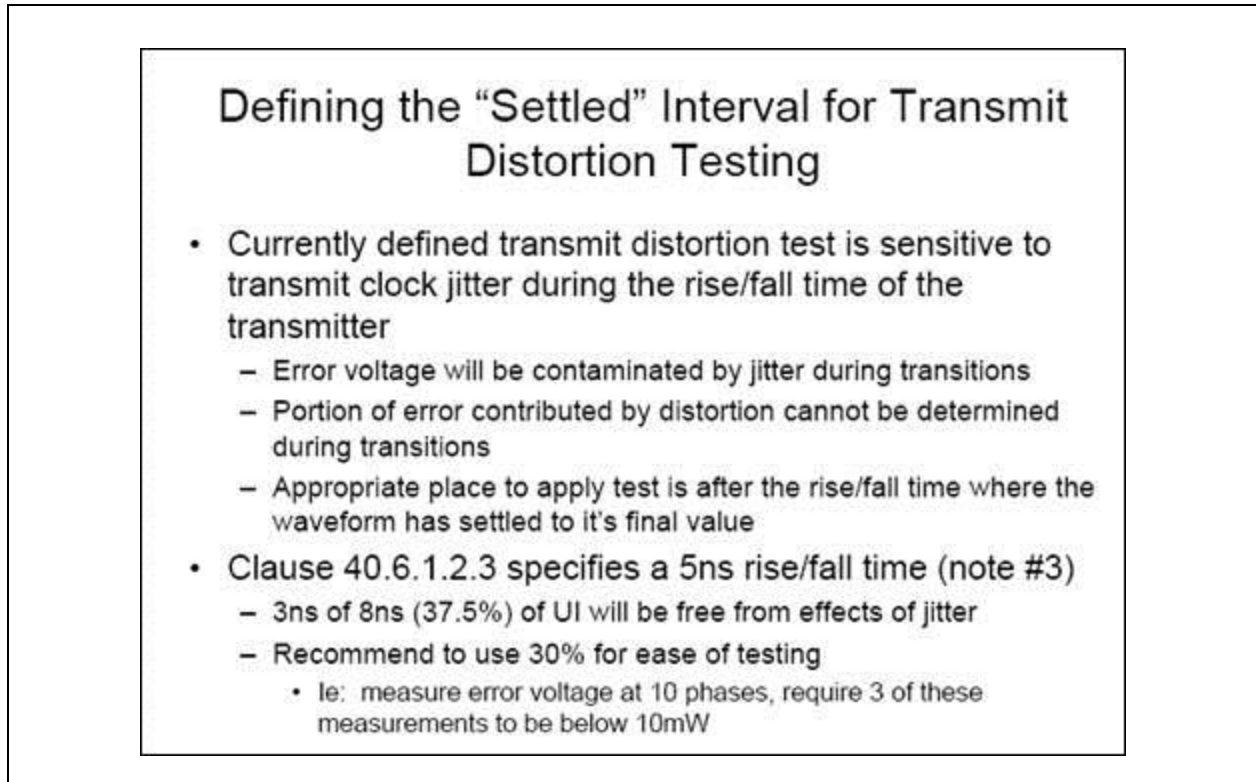
**FIGURE 2: IEEE DOCUMENT PAGE 7**

- On page 7:
  - The transmit distortion test is sensitive to transmit clock jitter during the rise/fall time.
  - It is recommended to change the requirement to use at least 30%, instead of at least 60%, of the UI within the eye opening for the <10mV peak transmitter distortion.
