## Product Change Notification - SYST-04TTDL159

ERRATA - KSZ9896C Silicon Errata & Data Sheet Clarification Errata Document Revision

## KSZ9896C Silicon Errata and Data Sheet Clarification

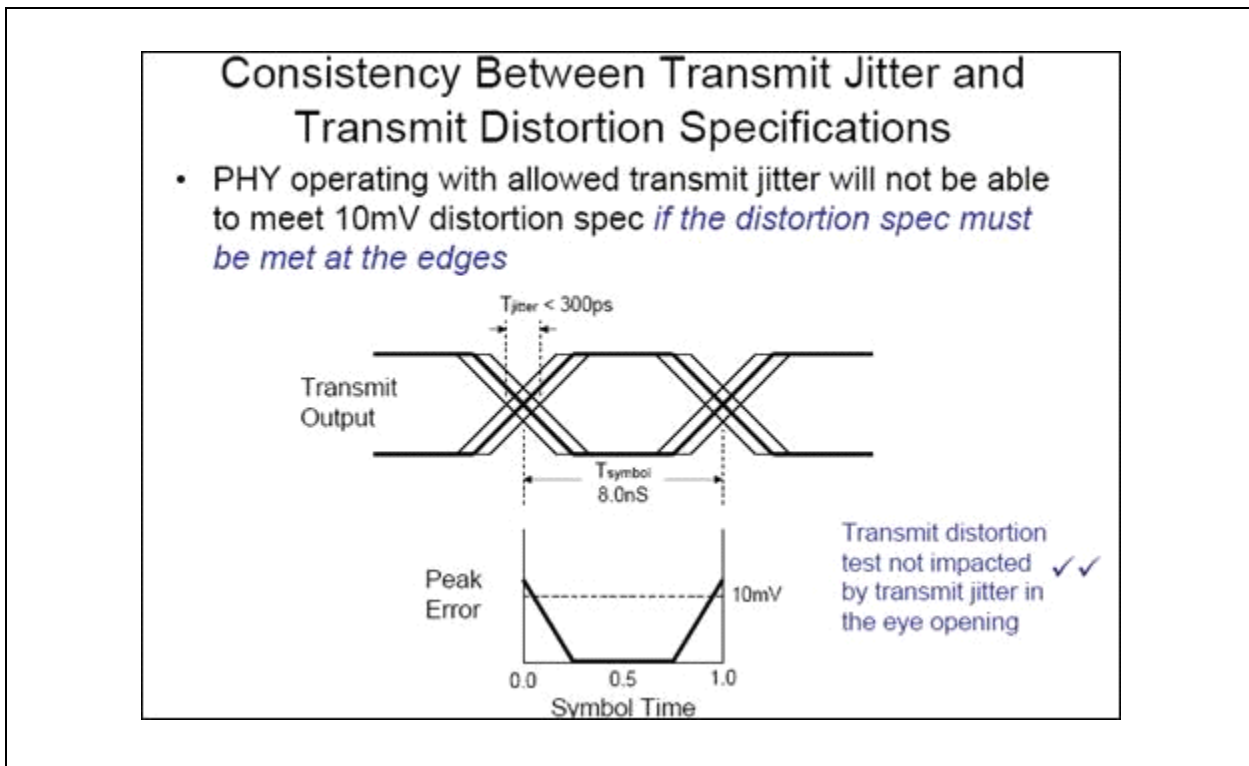
**FIGURE 1: IEEE DOCUMENT PAGE 6**

The device's 1000BASE-T Transmitter Distortion is approximately 40mV, versus the <10mV indicated in the IEEE specification.

IEEE testing calls for <10mV peak transmitter distortion for at least 60% of the UI within the eye opening. However, this measurement might not be valid, as the transmit distortion test is sensitive to transmit jitter. Refer to the explanation below, taken from the aforementioned IEEE document.

- On page 6, a contradiction between Transmit Jitter and Transmit Distortion requirements:

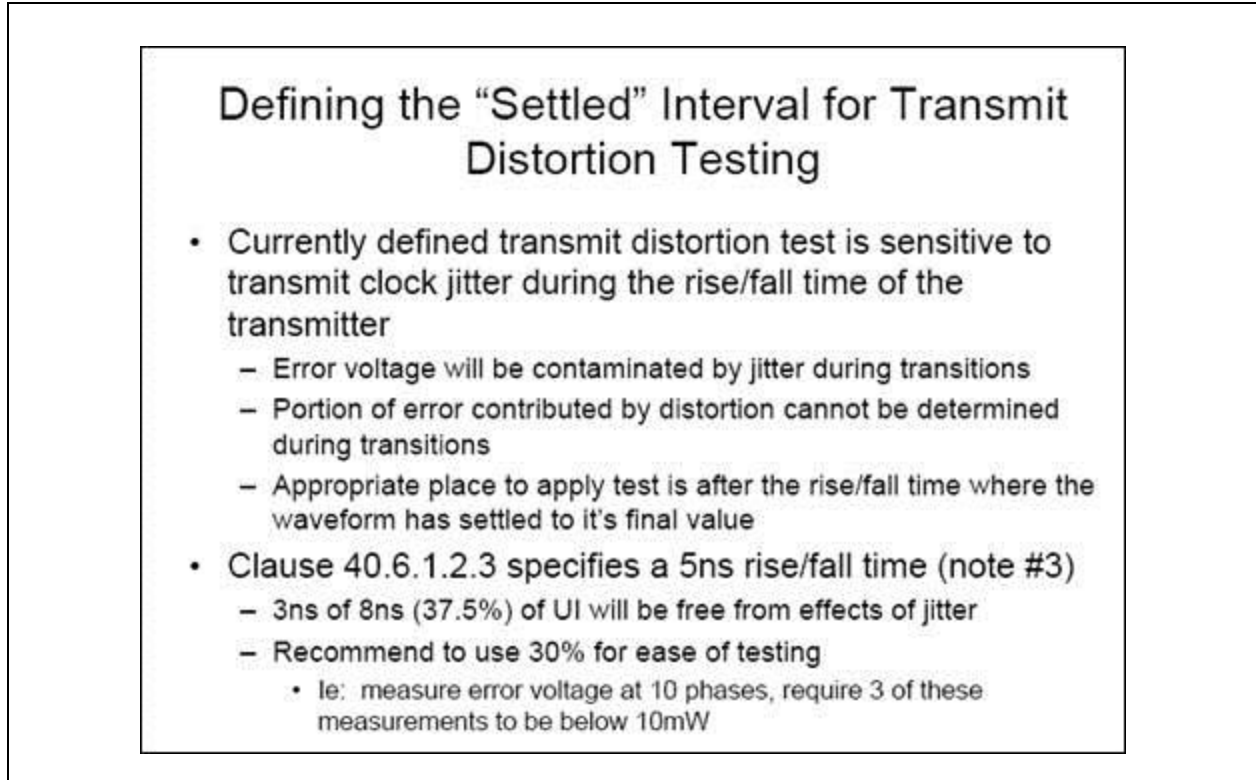
**FIGURE 2: IEEE DOCUMENT PAGE 7**

- On page 7:
  - The transmit distortion test is sensitive to transmit clock jitter during the rise/fall time.
  - It is recommended to change the requirement to use at least 30%, instead of at least 60%, of the UI within the eye opening for the <10mV peak transmitter distortion.
