## Product Change Notification - SYST-03FYTJ911

ERRATA - KSZ9563R Silicon Errata and Data Sheet Clarification Errata Document Revision

## KSZ9563R Silicon Errata and Data Sheet Clarification

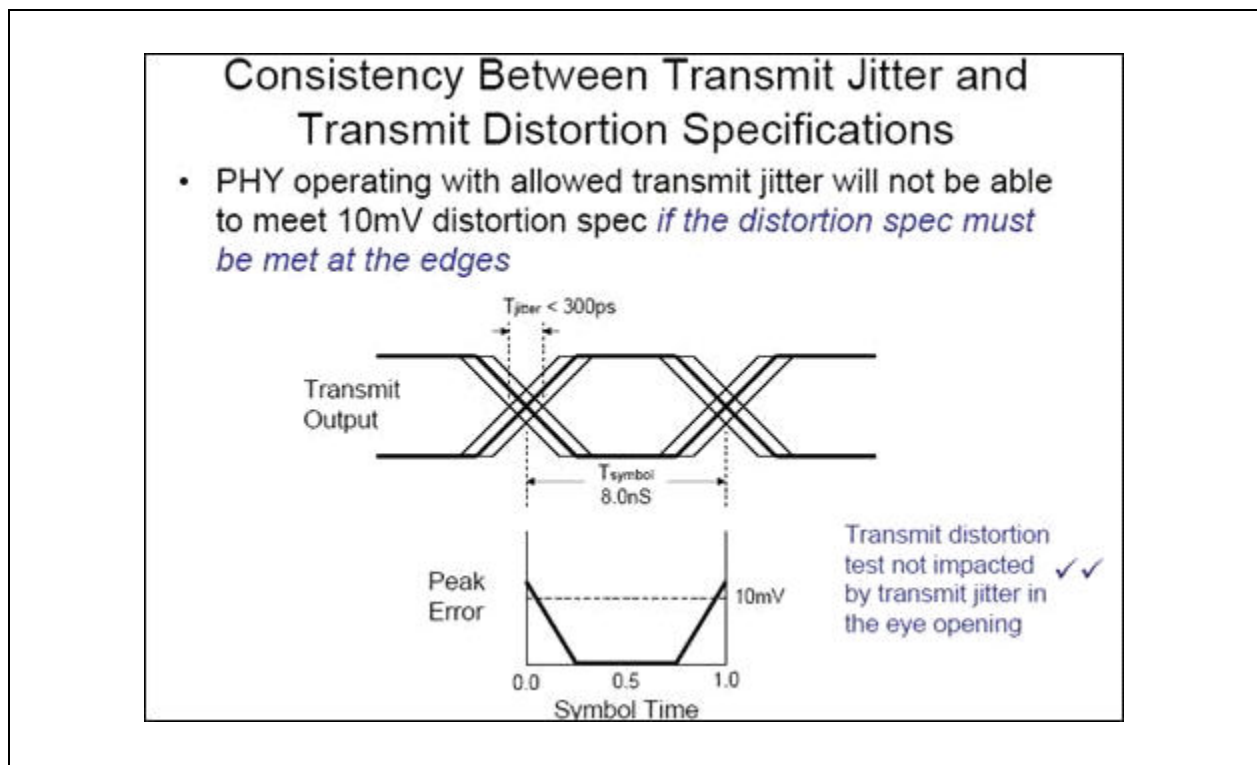
**FIGURE 2: IEEE DOCUMENT PAGE 6**

The device's 1000BASE-T Transmitter Distortion is approximately 40mV, versus the <10mV indicated in the IEEE specification.

IEEE testing calls for <10mV peak transmitter distortion for at least 60% of the UI within the eye opening. However, this measurement might not be valid, as the transmit distortion test is sensitive to transmit jitter. Refer to the explanation below, taken from the aforementioned IEEE document.

- On page 6, a contradiction between Transmit Jitter and Transmit Distortion requirements:
