Product Change Notification - SYST-04GTSK003

ERRATA - ENC424J600/624J600 Silicon/Data Sheet Errata

ENC424J600/624J600 Silicon Errata and Data Sheet Clarification

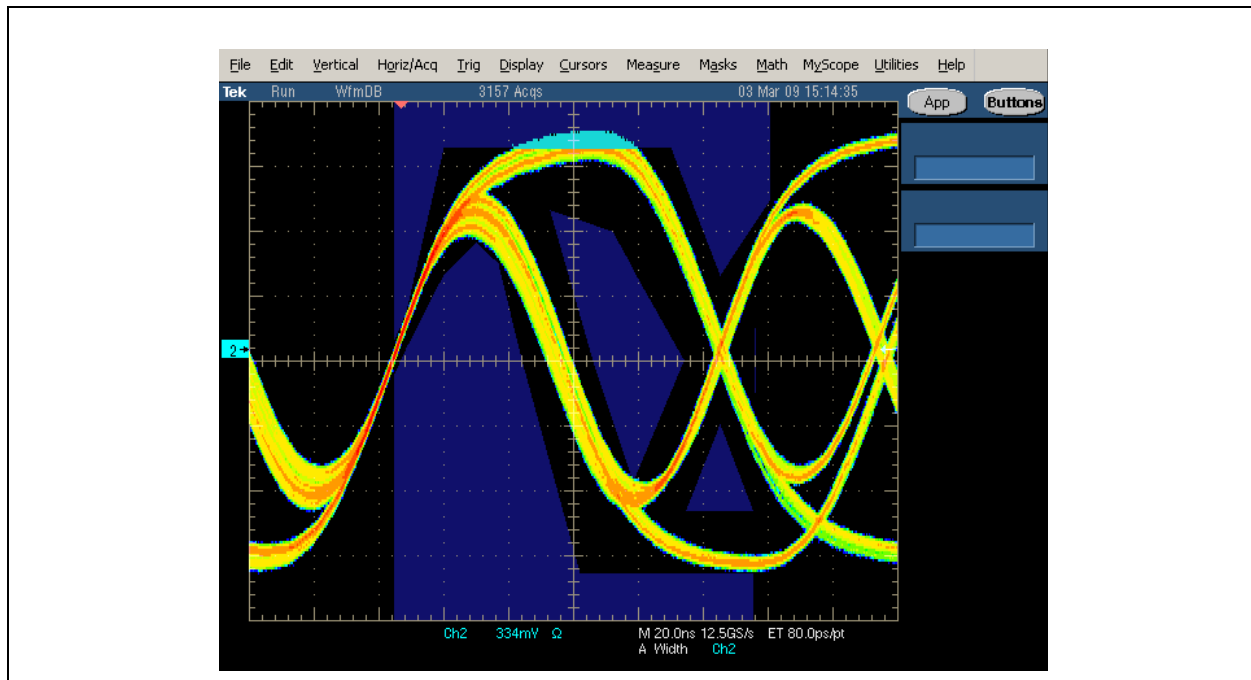
FIGURE 1: 10BASE-T MAU EYE DIAGRAM

When transmitting random data in 10BASE-T mode, the PHY transmit waveform slightly violates the MAU eye diagram keep-out zones specified in the IEEE 802.3™ Std. 2005, Section 14.3.1.2.1. Specifically, the waveform amplitude is slightly too high for '0' to '1' and '1' to '0' bit transitions when tested against the twisted-pair model, as shown in [Figure 1](#).

This issue applies only to 10 Mbps speed and is unlikely to cause compatibility problems in real networks. When terminated with a 100W resistor without the twisted-pair model, the transmit waveform stays within the amplitude limits of +2.2V to +2.8V and -2.2V to -2.8V required by the standard.

None.
