Product Change Notification - SYST-24WWIL685

ERRATA - dsPIC33EPXXX(GP/MC/MU)806/810/814 and PIC24EPXXX(GP/GU)810/814 Errata

dsPIC33EPXXX(GP/MC/MU)806/810/814 and PIC24EPXXX(GP/GU)810/814 Family Silicon Errata and Data Sheet Clarification

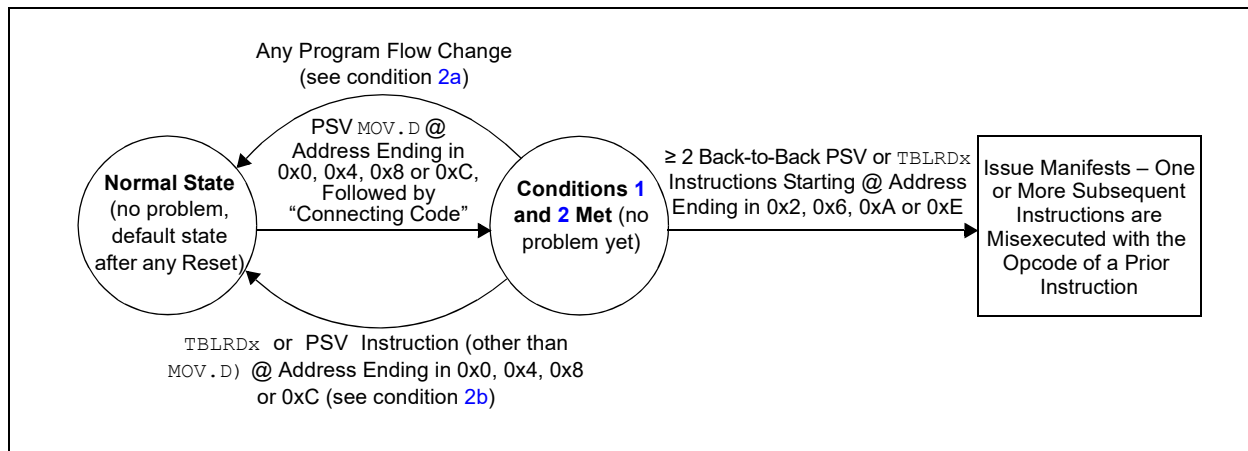
FIGURE 1: SIMPLIFIED BEHAVIOR

When two or more data Flash read instructions (via Program Space Visibility (PSV) read or table read) are executed back-to-back, one or more subsequent instructions can be misexecuted when all of the conditions in Table 3 occur.

Figure 1 provides an example of the effective behavior.

The issue can be avoided by ensuring any one or more of the requirements are not met. For example:

1. All instances of PSV `MOV.D` can be replaced with two PSV `MOV` instructions instead. Non-PSV `MOV.D` instructions acting on RAM/SFRs do not need to be modified; or
2. If not already present, a program flow change instruction (such as `BRA $+2`) can be inserted above back-to-back data Flash read sequences; or
3. Back-to-back data Flash read instruction sequences can be broken up by inserting a non-Flash read instruction (such as a `NOB`) in between the Flash read instructions; or
4. The alignment of the code can be shifted to avoid the required opcode location addresses.

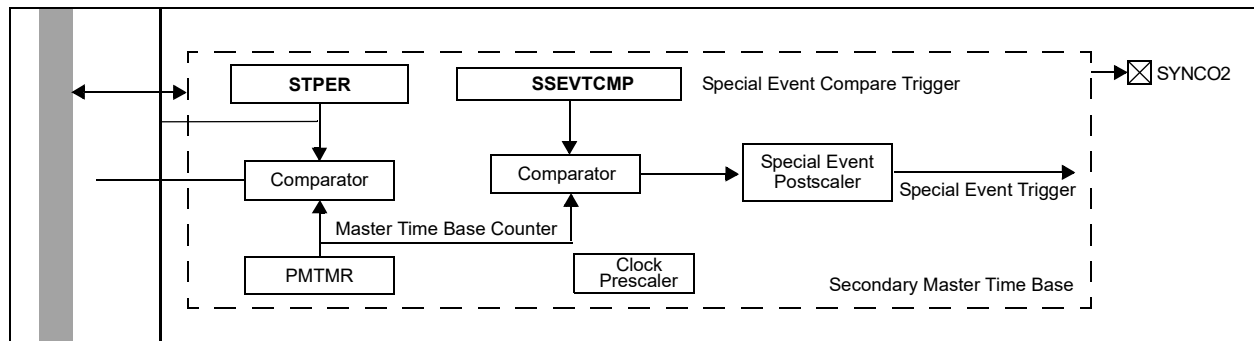
FIGURE 16-2: HIGH-SPEED PWM MODULE REGISTER INTERCONNECTION DIAGRAM

In **Figure 16-2: High-Speed PWM Module Register Interconnection Diagram**, the Secondary Master Time Base section has been updated. The updated text is shown in **bold** in [Figure 16-2](#) below.
