## Product Change Notification / SYST-08OAYW733

ERRATA - PIC24FJ256GB110 Family Silicon/Data Sheet Errata Document Revision

## PIC24FJ256GB110 Family Silicon Errata and Data Sheet Clarification

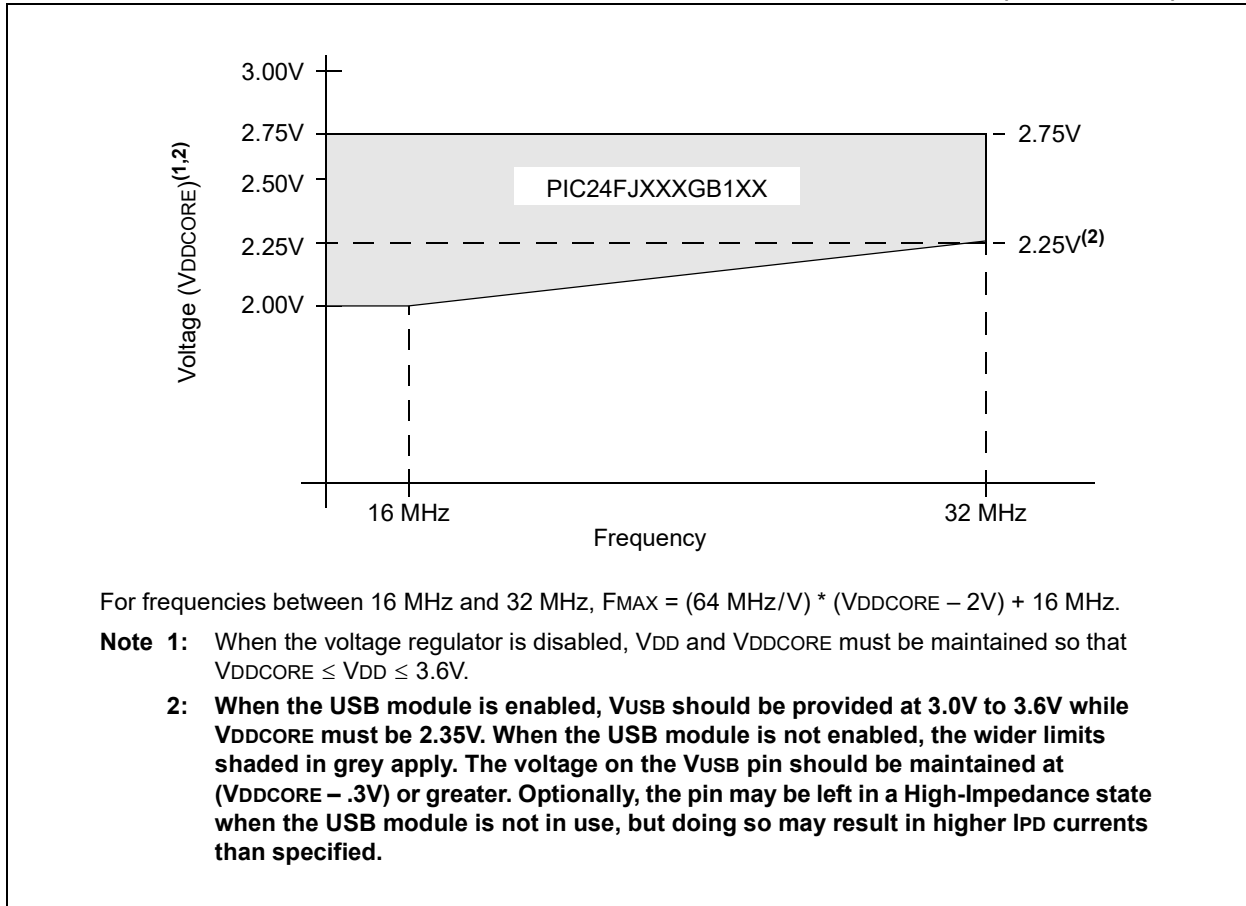
**FIGURE 29-1: PIC24FJ256GB110 FAMILY VOLTAGE-FREQUENCY GRAPH (INDUSTRIAL)**

Figure 29-1 (“PIC24FJ256GB110 Family Voltage-Frequency Graph”) is amended by adding an additional footnote. The updated figure is shown below (changes in **bold**; bold in original removed for clarity).
