Product Change Notification - SYST-22DREG067

Notification subject: ERRATA - PIC16F631/677/685/687/689/690 Family Silicon Errata and Data Sheet Clarification

PIC16F631/677/685/687/689/690 Family Silicon Errata and Data Sheet Clarification

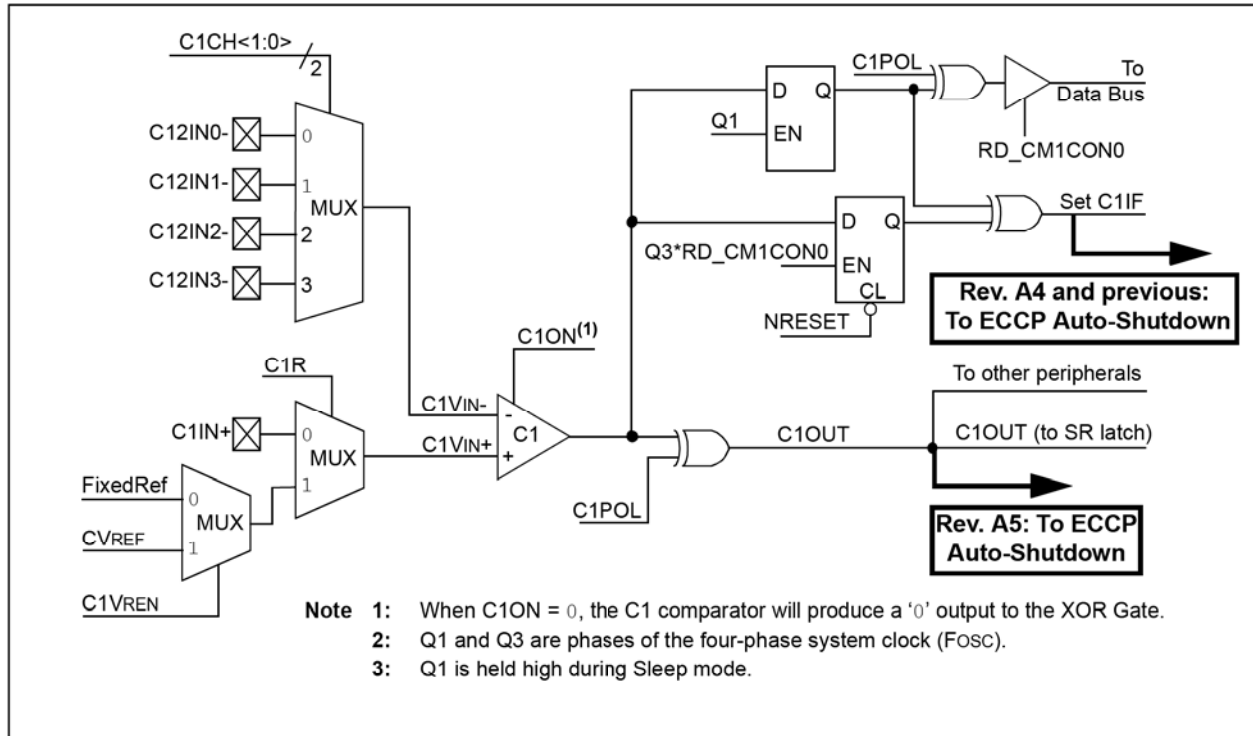
FIGURE 8-2: COMPARATOR C1 SIMPLIFIED BLOCK DIAGRAM

The PIC16F631/677/685/687/689/690 Rev. A4 silicon for the ECCP auto-shutdown is connected to the C1IF and C2IF flags. See Figures 8-2 and 8-3 on the following page.

The auto-shutdown connection (Rev. A4 and previous) to C1IF and C2IF causes the auto-shutdown to incorrectly operate synchronously. Additionally, reads of CMxCON0 will incorrectly clear an auto-shutdown event.

The Silicon Rev. A5 (now shipping) and later revision devices have moved the auto-shutdown connection from CxIF to CxOUT. This will eliminate the synchronous shutdown and simplify the use of the comparator for a shutdown event. Figure 1 shows the function of auto-shutdown before and after the device revision.
