[ERRATA - PIC24FJ256GB110 Family Silicon/Data Sheet Errata](#)

SYST-15QPMT193

Product Change Notification - SYST-15QPMT193

PIC24FJ256GB110 Family Silicon Errata and Data Sheet Clarification

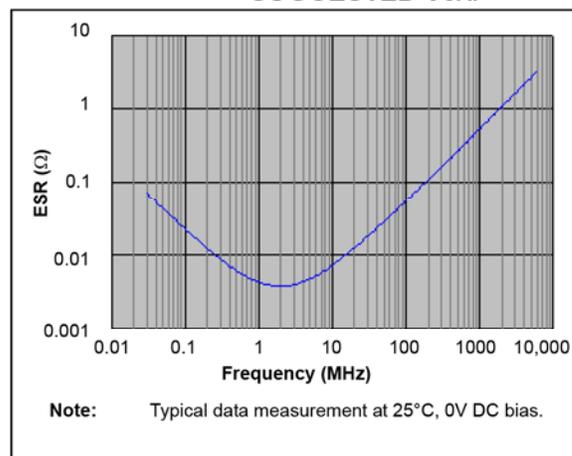
FIGURE 2-3 FREQUENCY vs. ESR PERFORMANCE FOR SUGGESTED VCAP

The placement of this capacitor should be close to VCAP/VDDCORE. It is recommended that the trace length not exceed 0.25 inch (6 mm). Refer to **Section 29.0 “Electrical Characteristics”** for additional information.

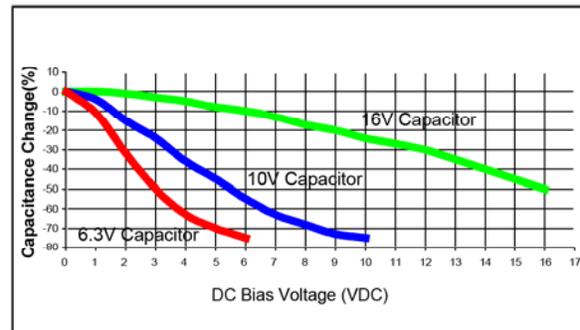
FIGURE 2-4 DC BIAS VOLTAGE vs. CAPACITANCE CHARACTERISTICS

The X5R and X7R capacitors typically exhibit satisfactory temperature stability (ex: $\pm 15\%$ over a wide temperature range, but consult the manufacturer's data sheets for exact specifications). However, Y5V capacitors typically have extreme temperature tolerance specifications of $+22\%/ -82\%$. Due to the extreme temperature tolerance, a 10 μF nominal rated Y5V type capacitor may not deliver enough total capacitance to meet minimum internal voltage regulator stability and transient response requirements. Therefore, Y5V capacitors are not recommended for use with the internal voltage regulator if the application must operate over a wide temperature range.

A typical DC bias voltage vs. capacitance graph for 16V, 10V and 6.3V rated capacitors is shown in Figure 2-4.

When selecting a ceramic capacitor to be used with the internal voltage regulator, it is suggested to select a high-voltage rating, so that the operating voltage is a small percentage of the maximum rated capacitor voltage. For example, choose a ceramic capacitor rated at 16V for the 2.5V core voltage. Suggested capacitors are shown in Table 2-1.
