Notification subject: ERRATA - PIC12(L)F1822/PIC16(L)F1823 Silicon Errata and Data Sheet Clarification

PIC12(L)F1822/PIC16(L)F1823 Family Silicon Errata and Data Sheet Clarification

The PIC12(L)F1822/PIC16(L)F1823 family devices that you have received conform functionally to the current Device Data Sheet (DS41413B), except for the anomalies described in this document.

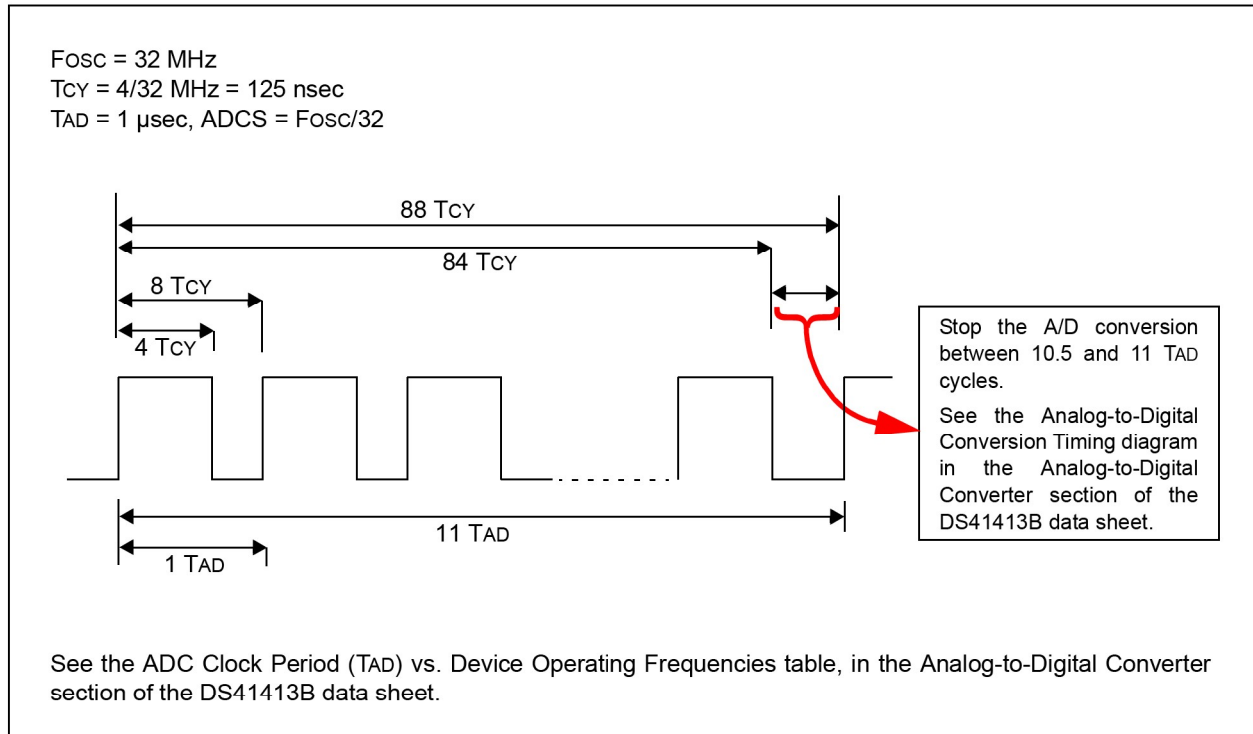
FIGURE 1: INSTRUCTION CYCLE DELAY CALCULATION EXAMPLE

Under certain device operating conditions, the ADC conversion may not complete properly. When this occurs, the ADC Interrupt Flag (ADIF) does not get set, the GO/DONE bit does not get cleared and the conversion result does not get loaded into the ADRESH and ADRESL result registers.

In Figure 1, 88 instruction cycles (TCY) will be required to complete the full conversion. Each TAD cycle consists of 8 TCY periods. A fixed delay is provided to stop the A/D conversion after 86 instruction cycles and terminate the conversion at the correct time as shown in the figure above.

Note: The exact delay time will depend on the choice of FOSC and the TAD divisor (ADCS) selection. The TCY counts shown in the timing diagram above apply to this example only. Refer to Table 3 for the required delay counts for other configurations.

Method 2: Provide a fixed delay in software to stop the A-to-D conversion manually, after all 10 bits are converted, but before the conversion would complete automatically. The conversion is stopped by clearing the GO/DONE bit in software. The GO/DONE bit must be cleared during the last ½ TAD cycle, before the conversion would have completed automatically. Refer to [Figure 1](#) for details.
