Product Change Notification - SYST-13SYHI351

Notification subject:	ERRATA - PIC24FJ256GB110 Family Silicon/Data Sheet Errata
Notification text:	<p>SYST-13SYHI351</p> <p>Microchip has released a new DeviceDoc for the PIC24FJ256GB110 Family Silicon/Data Sheet Errata of devices. If you are using one of these devices please read the document located at PIC24FJ256GB110 Family Silicon/Data Sheet Errata.</p>
Attachment(s):	PIC24FJ256GB110 Family Silicon/Data Sheet Errata

PIC24FJ256GB110 Family Silicon Errata and Data Sheet Clarification

The PIC24FJ256GB110 family devices that you have received conform functionally to the current Device Data Sheet (DS39897C), except for the anomalies described in this document.

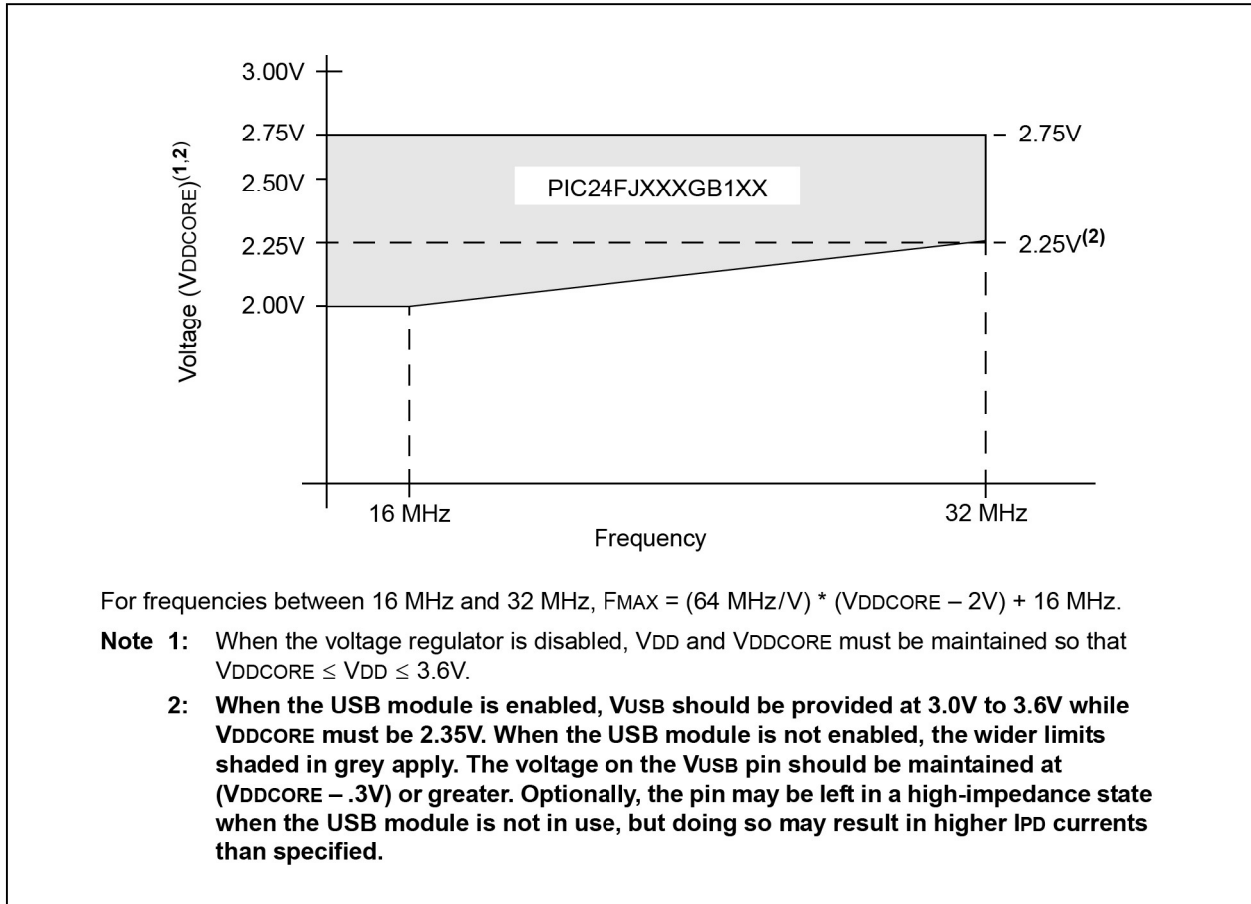
FIGURE 29-1: PIC24FJ256GB110 FAMILY VOLTAGE-FREQUENCY GRAPH (INDUSTRIAL)

Figure 29-1 ("PIC24FJ256GB110 Family Voltage-Frequency Graph") is amended by adding an additional footnote. The updated figure is shown below (changes in **bold**; bold in original removed for clarity).
