Product Change Notification - SYST-14OGUK607

Notification subject: ERRATA - PIC24FJ256GB110 Family Silicon/Data Sheet Errata

PIC24FJ256GB110 Family Silicon Errata and Data Sheet Clarification

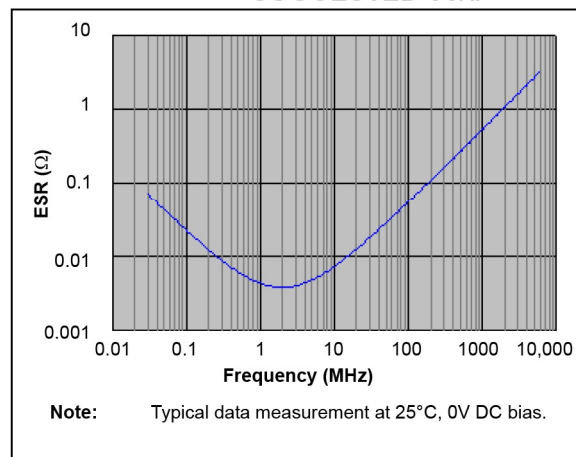
FIGURE 2-3 FREQUENCY vs. ESR PERFORMANCE FOR SUGGESTED VCAP

The placement of this capacitor should be close to VCAP/VDDCORE. It is recommended that the trace length not exceed 0.25 inch (6 mm). Refer to **Section 29.0 “Electrical Characteristics”** for additional information.

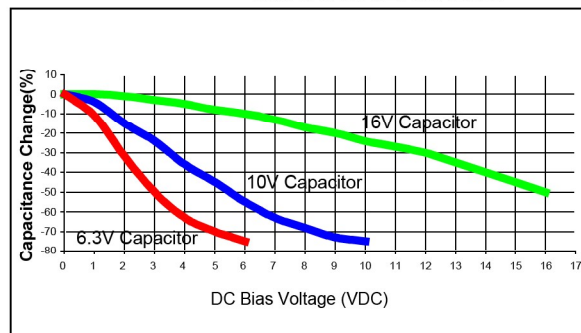
FIGURE 2-4 DC BIAS VOLTAGE vs. CAPACITANCE CHARACTERISTICS

A typical DC bias voltage vs. capacitance graph for 16V, 10V and 6.3V rated capacitors is shown in Figure 2-4.

When selecting a ceramic capacitor to be used with the internal voltage regulator, it is suggested to select a high-voltage rating, so that the operating voltage is a small percentage of the maximum rated capacitor voltage. For example, choose a ceramic capacitor rated at 16V for the 2.5V core voltage. Suggested capacitors are shown in Table 2-1.

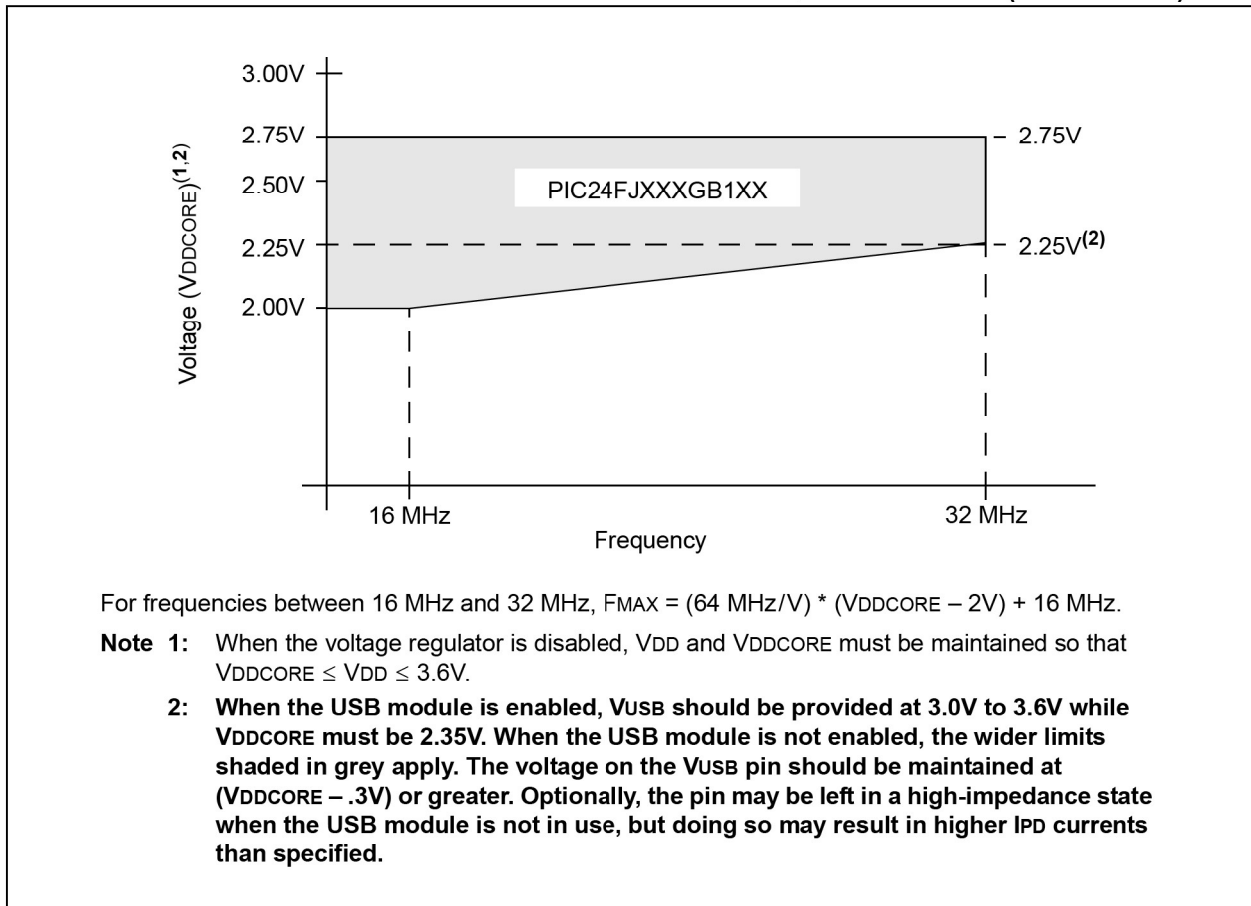
FIGURE 29-1: PIC24FJ256GB110 FAMILY VOLTAGE-FREQUENCY GRAPH (INDUSTRIAL)

Figure 29-1 ("PIC24FJ256GB110 Family Voltage-Frequency Graph") is amended by adding an additional footnote. The updated figure is shown below (changes in **bold**; bold in original removed for clarity).
