**Notification subject:** ERRATA - PIC12(L)F1822/PIC16(L)F1823 Silicon Errata and Data Sheet Clarification Errata Document Revision

## **Product Change Notification - SYST-18YBGA236**

## PIC12(L)F1822/PIC16(L)F1823 Family Silicon Errata and Data Sheet Clarification

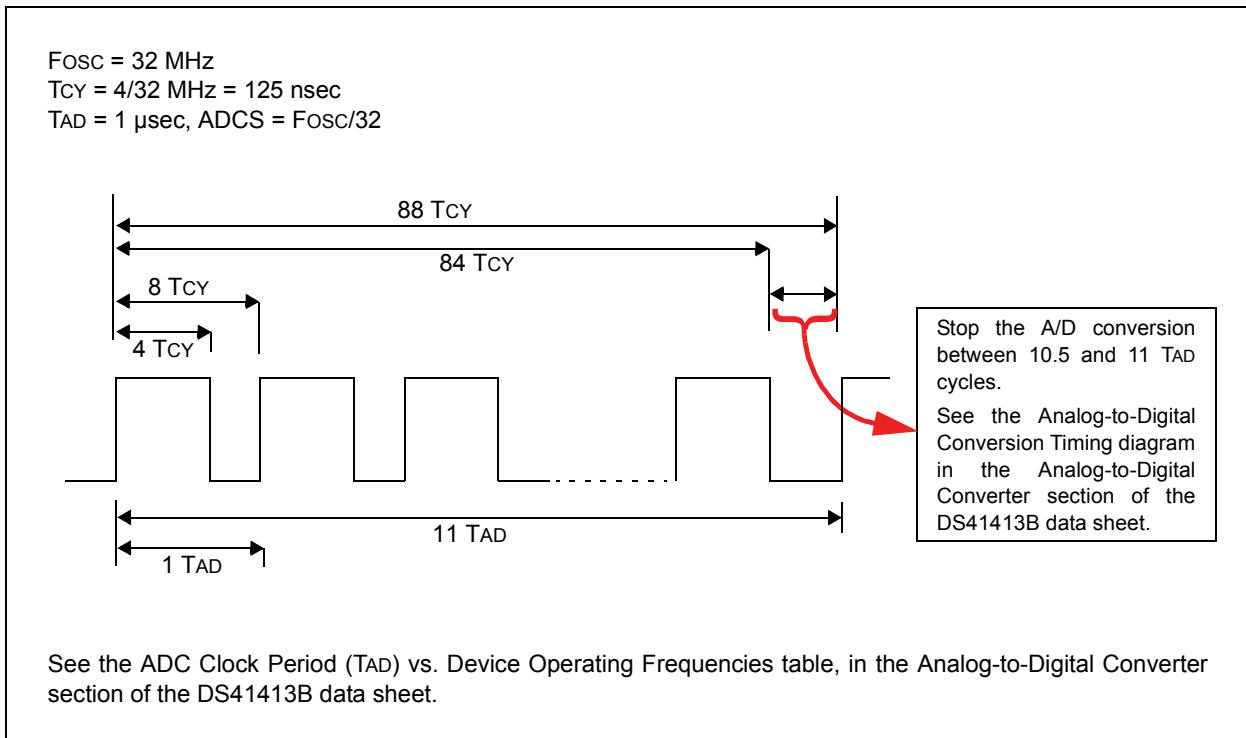
**FIGURE 1: INSTRUCTION CYCLE DELAY CALCULATION EXAMPLE**

Under certain device operating conditions, the ADC conversion may not complete properly. When this occurs, the ADC Interrupt Flag (ADIF) does not get set, the GO/DONE bit does not get cleared and the conversion result does not get loaded into the ADRESH and ADRESL result registers.

In Figure 1, 88 instruction cycles (TCY) will be required to complete the full conversion. Each TAD cycle consists of 8 TCY periods. A fixed delay is provided to stop the A/D conversion after 86 instruction cycles and terminate the conversion at the correct time as shown in the figure above.

**Note:** The exact delay time will depend on the choice of FOSC and the TAD divisor (ADCS) selection. The TCY counts shown in the timing diagram above apply to this example only. Refer to Table 3 for the required delay counts for other configurations.

Method 2: Provide a fixed delay in software to stop the A-to-D conversion manually, after all 10 bits are converted, but before the conversion would complete automatically. The conversion is stopped by clearing the GO/DONE bit in software. The GO/DONE bit must be cleared during the last 1/2 TAD cycle, before the conversion would have completed automatically. Refer to Figure 1 for details.

For other combinations of FOSC, TAD values and instruction cycle delay counts, refer to Table 3.
