Notification subject: ERRATA - PIC12(L)F1822/PIC16(L)F1823 Silicon Errata and Data Sheet Clarification
Silicon Die Revision Addition

MICROCHIP PIC12(L)F1822/PIC16(L)F1823

PIC12(L)F1822/PIC16(L)F1823 Family Silicon Errata and Data Sheet Clarification

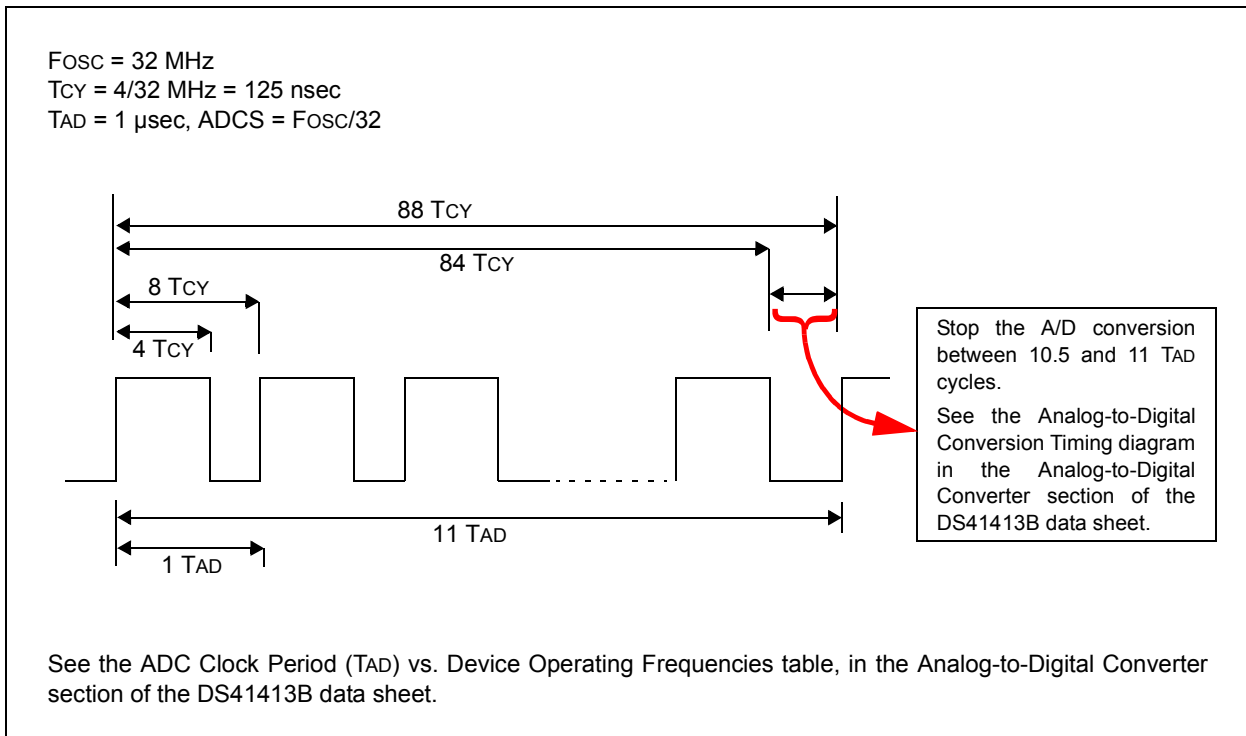
FIGURE 1: INSTRUCTION CYCLE DELAY CALCULATION EXAMPLE

Under certain device operating conditions, the ADC conversion may not complete properly. When this occurs, the ADC Interrupt Flag (ADIF) does not get set, the GO/DONE bit does not get cleared and the conversion result does not get loaded into the ADRESH and ADRESL result registers.

In Figure 1, 88 instruction cycles (TCY) will be required to complete the full conversion. Each TAD cycle consists of 8 TCY periods. A fixed delay is provided to stop the A/D conversion after 86 instruction cycles and terminate the conversion at the correct time as shown in the figure above.

Note: The exact delay time will depend on the choice of FOSC and the TAD divisor (ADCS) selection. The TCY counts shown in the timing diagram above apply to this example only. Refer to Table 3 for the required delay counts for other configurations.

Method 2: Provide a fixed delay in software to stop the A-to-D conversion manually, after all 10 bits are converted, but before the conversion would complete automatically. The conversion is stopped by clearing the GO/DONE bit in software. The GO/DONE bit must be cleared during the last 1/2 TAD cycle, before the conversion would have completed automatically. Refer to Figure 1 for details.

```
BSF    ADCON0, GO/DONE; Start ADC conversion
        ; Provide 86
        ; instruction cycle
        ; delay here
BCF    ADCON0, GO/DONE; Terminate the
        ; conversion manually
MOVF  ADRESH, W      ; Read conversion
        ; result
```
