**Notification subject:** ERRATA - PIC24FJ256GB110 Family Silicon/Data Sheet Errata

## Product Change Notification - SYST-22TJFL941

## PIC24FJ256GB110 Family Silicon Errata and Data Sheet Clarification

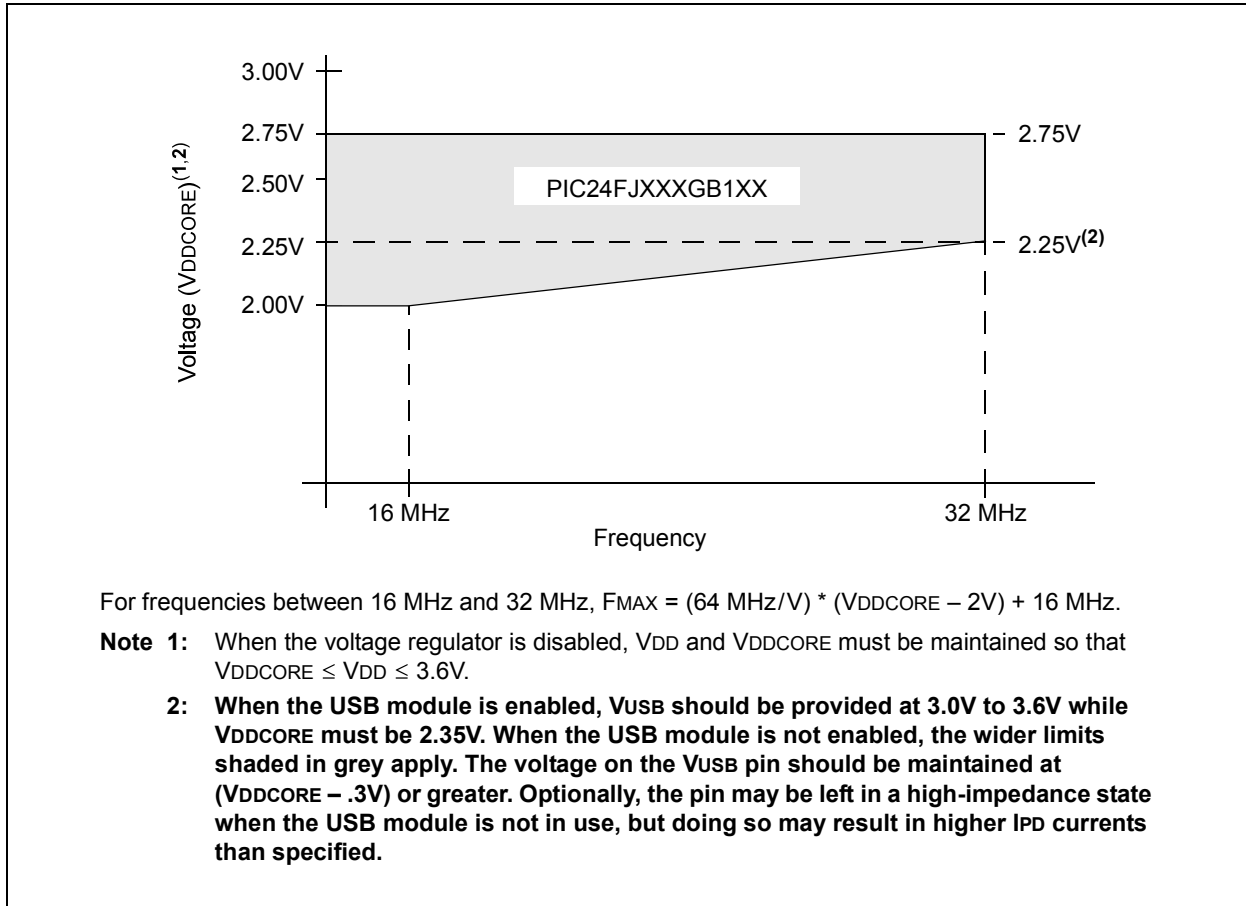
**FIGURE 29-1: PIC24FJ256GB110 FAMILY VOLTAGE-FREQUENCY GRAPH (INDUSTRIAL)**

Figure 29-1 (“PIC24FJ256GB110 Family Voltage-Frequency Graph”) is amended by adding an additional footnote. The updated figure is shown below (changes in **bold**; bold in original removed for clarity).
