Tyco Electronics Corporation 803-985-8500 tel
200 Interconnect Drive 803-985-8507 fax
Rock Hill, S.C. 29730

Tyco Electronics / Rock Hill – Root Cause & Corrective Action

D1 Problem Description

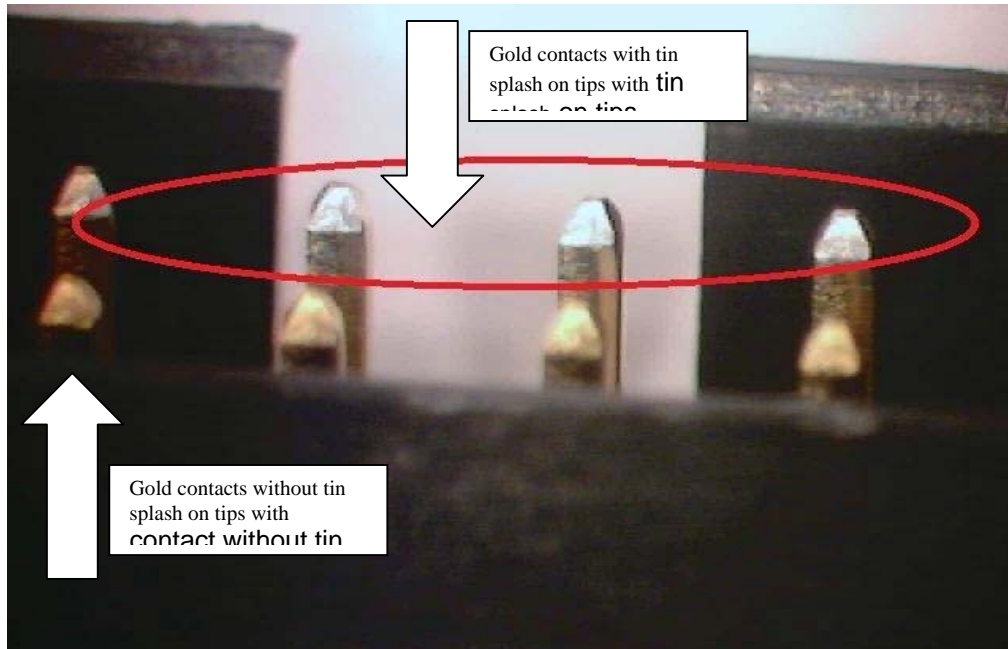
In Assembly, a Quality Auditor found "silvery plating" on the gold tips of Universal Header contacts. The first indication was seen on 24 January 2011. The traceability data for the affected orders was researched, revealing that the product was belt plated on Line 58 - beginning with Week 50 of 2010.

D4 Root Cause - Occurrence

Because the plating baths operate at elevated temperatures, the seams on the tin plating belts can expand over time and allow tin solution to leak through the belt each time the belt seam passes the plating spray nozzle. This allowed a small amount tin solution to plate onto the tips of the contacts already plated with gold.

Up to four contacts were affected every 11.4 feet (roughly 4 out of every 1360 contacts)

Because there were inadequate controls over the cleaning and inspection of belts, this belt was allowed to deteriorate through use.

A: Remove all plating belts with seams from the plating operation.

B: Order seamless belts on all future purchase orders.

C: Implement a log sheet to record when plating belts are issued and returned. This record will reference the unique identification number which is displayed on the belt. The Plating Daily Production Record (DPR) will also be revised to record the belt ID # on every order.
