Product Change Notification - SYST-15YLYB526

Notification subject: ERRATA - LAN91C111/LAN91C111i Family Silicon Errata and Data Sheet Clarification Errata Document Revision

LAN91C111/LAN91C111i Family Silicon Errata and Data Sheet Clarification

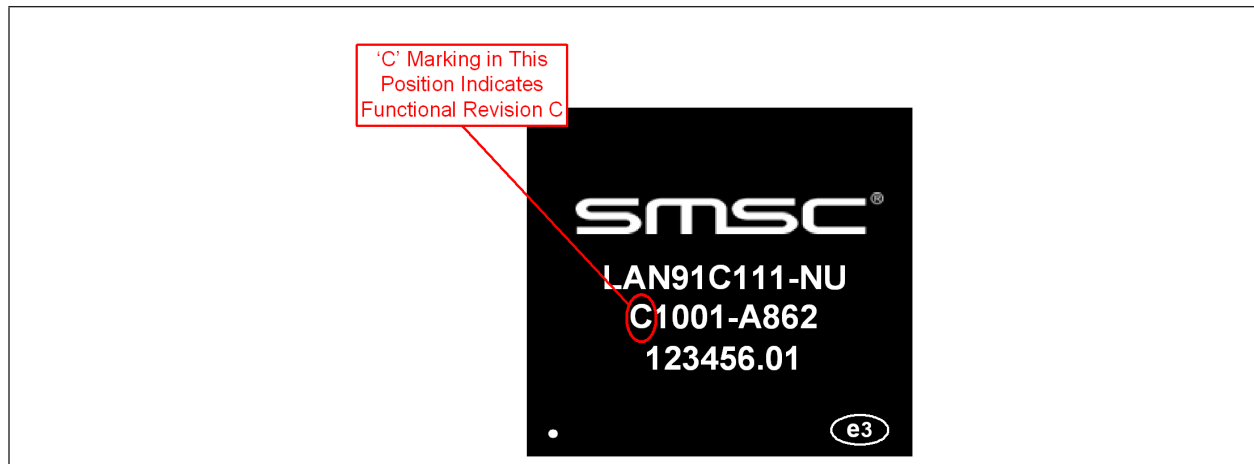
FIGURE 1: TOP MARKING FOR FUNCTIONAL REVISION C DEVICE

This document describes known anomalies for functional revision C of the LAN91C111/LAN91C111i device. The functional revision can be determined by its top marking as indicated in [Figure 1](#).

Note: [Figure 1](#) details the top markings of an example part. Other than the highlighted functional revision marking, other top marking values may differ (manufacture date, lot codes, industrial temperature part, etc.).
