Visual adjustment: Temporary different color for signal connectors

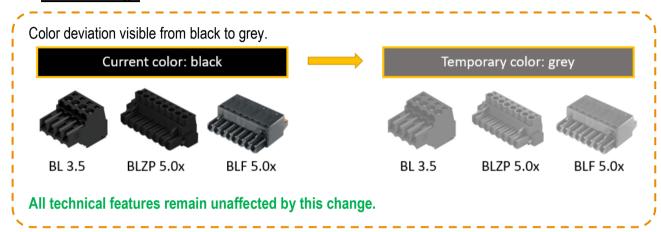
1. Visual change

Due to global supply shortages for plastics, we have to temporarily switch to a different color for black signal connectors to avoid possible longer-term supply interruptions.
