Product Change Notification - SYST-11YPLB717

Notification subject: ERRATA - LAN8740A/LAN8740Ai - Silicon Errata and Data Sheet Clarification Errata Document Revision

LAN8740A/LAN8740Ai Silicon Errata and Data Sheet Clarification

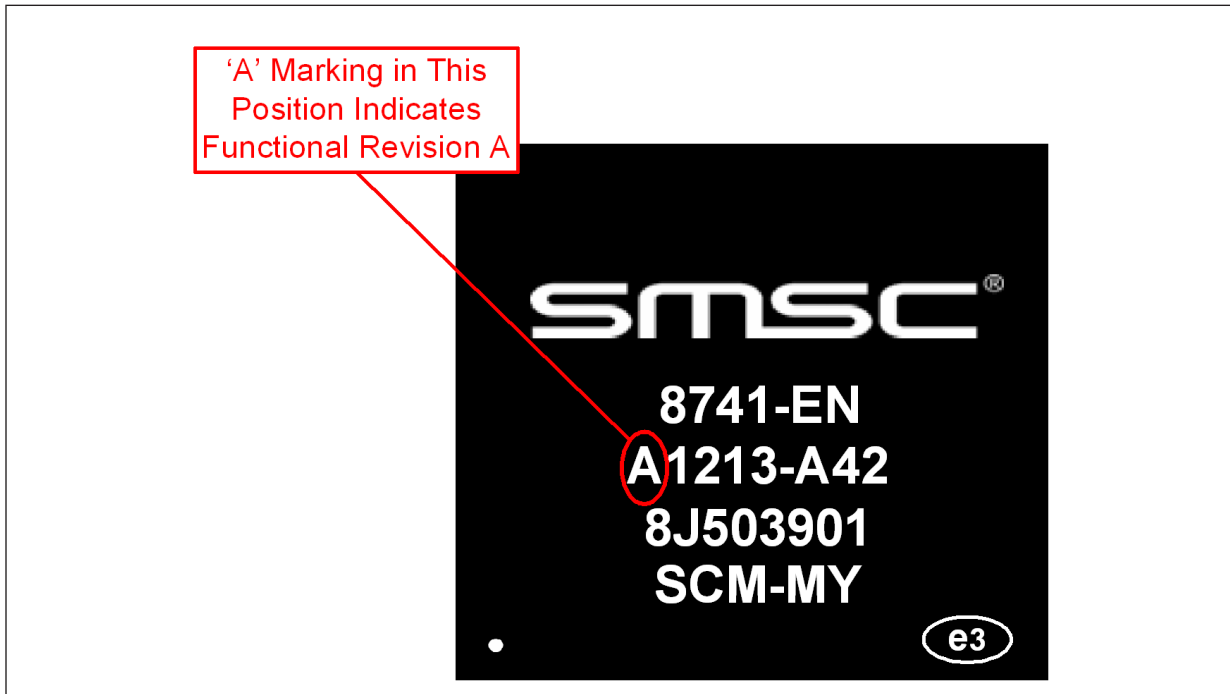
FIGURE 1: TOP MARKING FOR FUNCTIONAL REVISION A DEVICE

This document describes known anomalies for functional revision A and B of the LAN8740A/LAN8740Ai device. The functional revision can be determined by its top marking as indicated in [Figure 1](#) and [Figure 2](#).

Note: Figure 1 and Figure 2 detail the top markings of example parts. Other than the highlighted revision marking, other top marking values may differ (manufacture date, lot codes, industrial temperature part, etc.)
