Product Change Notification - SYST-13SYHI351

Notification subject:	ERRATA - PIC24FJ256GB110 Family Silicon/Data Sheet Errata
Notification text:	<p>SYST-13SYHI351</p> <p>Microchip has released a new DeviceDoc for the PIC24FJ256GB110 Family Silicon/Data Sheet Errata of devices. If you are using one of these devices please read the document located at PIC24FJ256GB110 Family Silicon/Data Sheet Errata.</p>
Attachment(s):	PIC24FJ256GB110 Family Silicon/Data Sheet Errata

PIC24FJ256GB110 Family Silicon Errata and Data Sheet Clarification

The PIC24FJ256GB110 family devices that you have received conform functionally to the current Device Data Sheet (DS39897C), except for the anomalies described in this document.

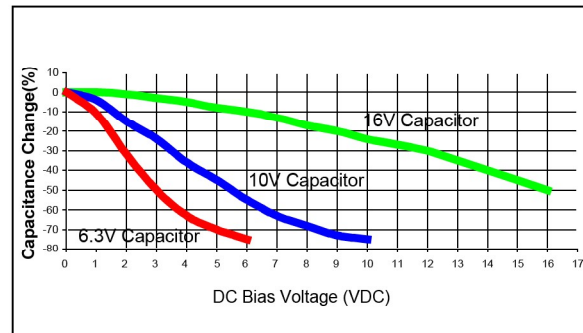
FIGURE 2-4 DC BIAS VOLTAGE vs. CAPACITANCE CHARACTERISTICS

The X5R and X7R capacitors typically exhibit satisfactory temperature stability (ex: $\pm 15\%$ over a wide temperature range, but consult the manufacturer's data sheets for exact specifications). However, Y5V capacitors typically have extreme temperature tolerance specifications of $+22\%/ -82\%$. Due to the extreme temperature tolerance, a 10 μF nominal rated Y5V type capacitor may not deliver enough total capacitance to meet minimum internal voltage regulator stability and transient response requirements. Therefore, Y5V capacitors are not recommended for use with the internal voltage regulator if the application must operate over a wide temperature range.

A typical DC bias voltage vs. capacitance graph for 16V, 10V and 6.3V rated capacitors is shown in Figure 2-4.

When selecting a ceramic capacitor to be used with the internal voltage regulator, it is suggested to select a high-voltage rating, so that the operating voltage is a small percentage of the maximum rated capacitor voltage. For example, choose a ceramic capacitor rated at 16V for the 2.5V core voltage. Suggested capacitors are shown in Table 2-1.
