**Notification subject:** ERRATA - PIC24FJ256GB110 Family Silicon/Data Sheet Errata Errata Document Revision

Microchip has released a new DeviceDoc for the PIC24FJ256GB110 Family Silicon/Data Sheet Errata of devices. If you are using one of these devices please read the document located at [PIC24FJ256GB110 Family Silicon/Data Sheet Errata](#).

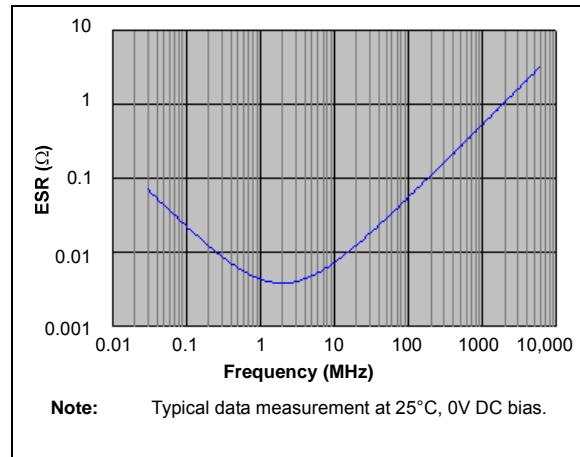
**FIGURE 2-3 FREQUENCY vs. ESR PERFORMANCE FOR SUGGESTED VCAP**

Designers may use [Figure 2-3](#) to evaluate ESR equivalence of candidate devices.

The placement of this capacitor should be close to VCAP/VDDCORE. It is recommended that the trace length not exceed 0.25 inch (6 mm). Refer to **Section 29.0 “Electrical Characteristics”** for additional information.

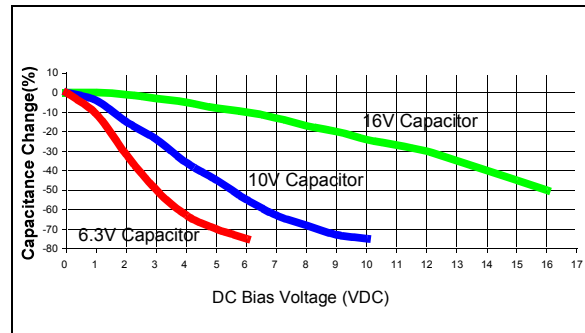
**FIGURE 2-4 DC BIAS VOLTAGE vs. CAPACITANCE CHARACTERISTICS**

A typical DC bias voltage vs. capacitance graph for 16V, 10V and 6.3V rated capacitors is shown in Figure 2-4.

When selecting a ceramic capacitor to be used with the internal voltage regulator, it is suggested to select a high-voltage rating, so that the operating voltage is a small percentage of the maximum rated capacitor voltage. For example, choose a ceramic capacitor rated at 16V for the 2.5V core voltage. Suggested capacitors are shown in Table 2-1.

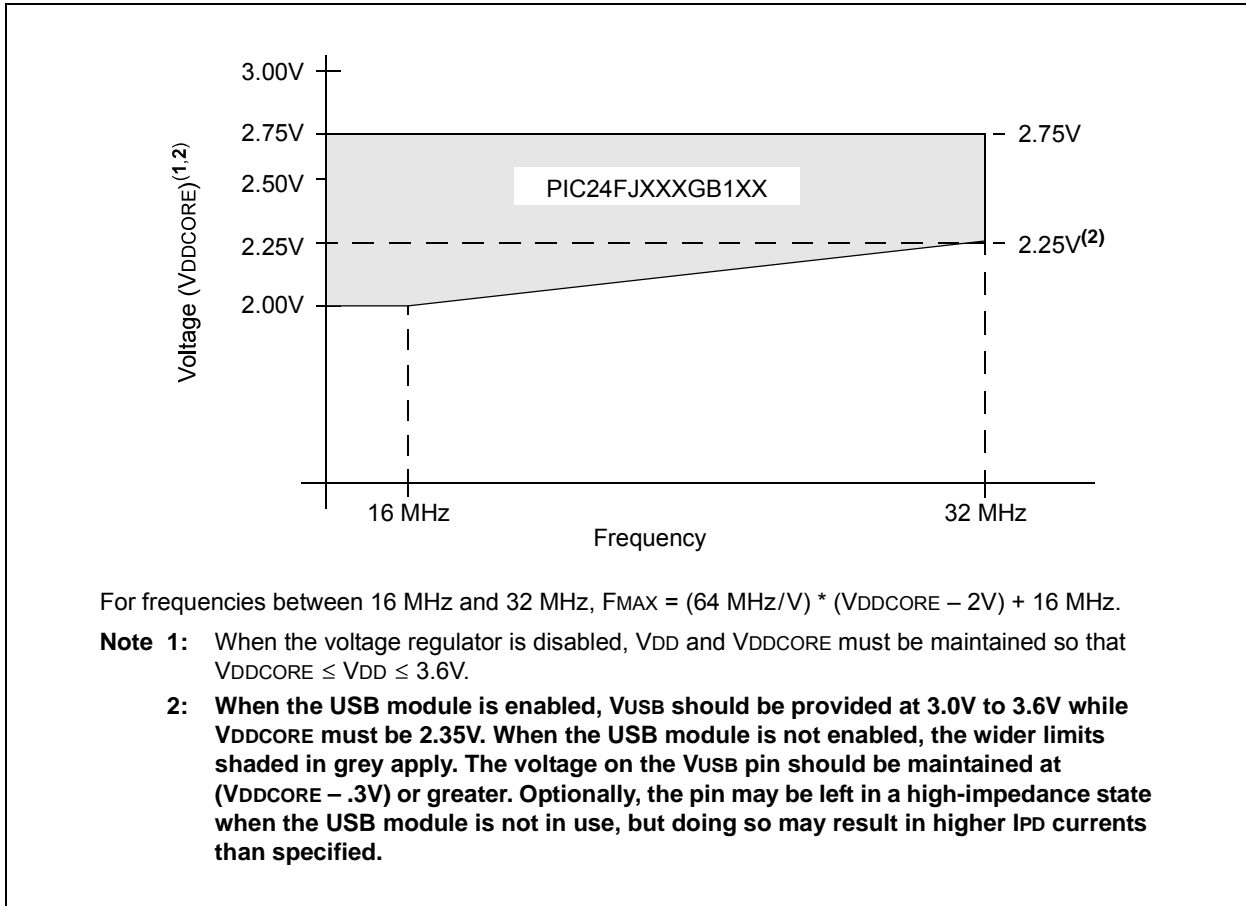
**FIGURE 29-1: PIC24FJ256GB110 FAMILY VOLTAGE-FREQUENCY GRAPH (INDUSTRIAL)**

Figure 29-1 (“PIC24FJ256GB110 Family Voltage-Frequency Graph”) is amended by adding an additional footnote. The updated figure is shown below (changes in **bold**; bold in original removed for clarity).
