**Notification subject:** ERRATA - PIC18F24K20/25K20/44K20/45K20 Silicon Data Sheet Errata  
Silicon Die Revision Addition

**Description of Change:** Addition of silicon die revision AF.

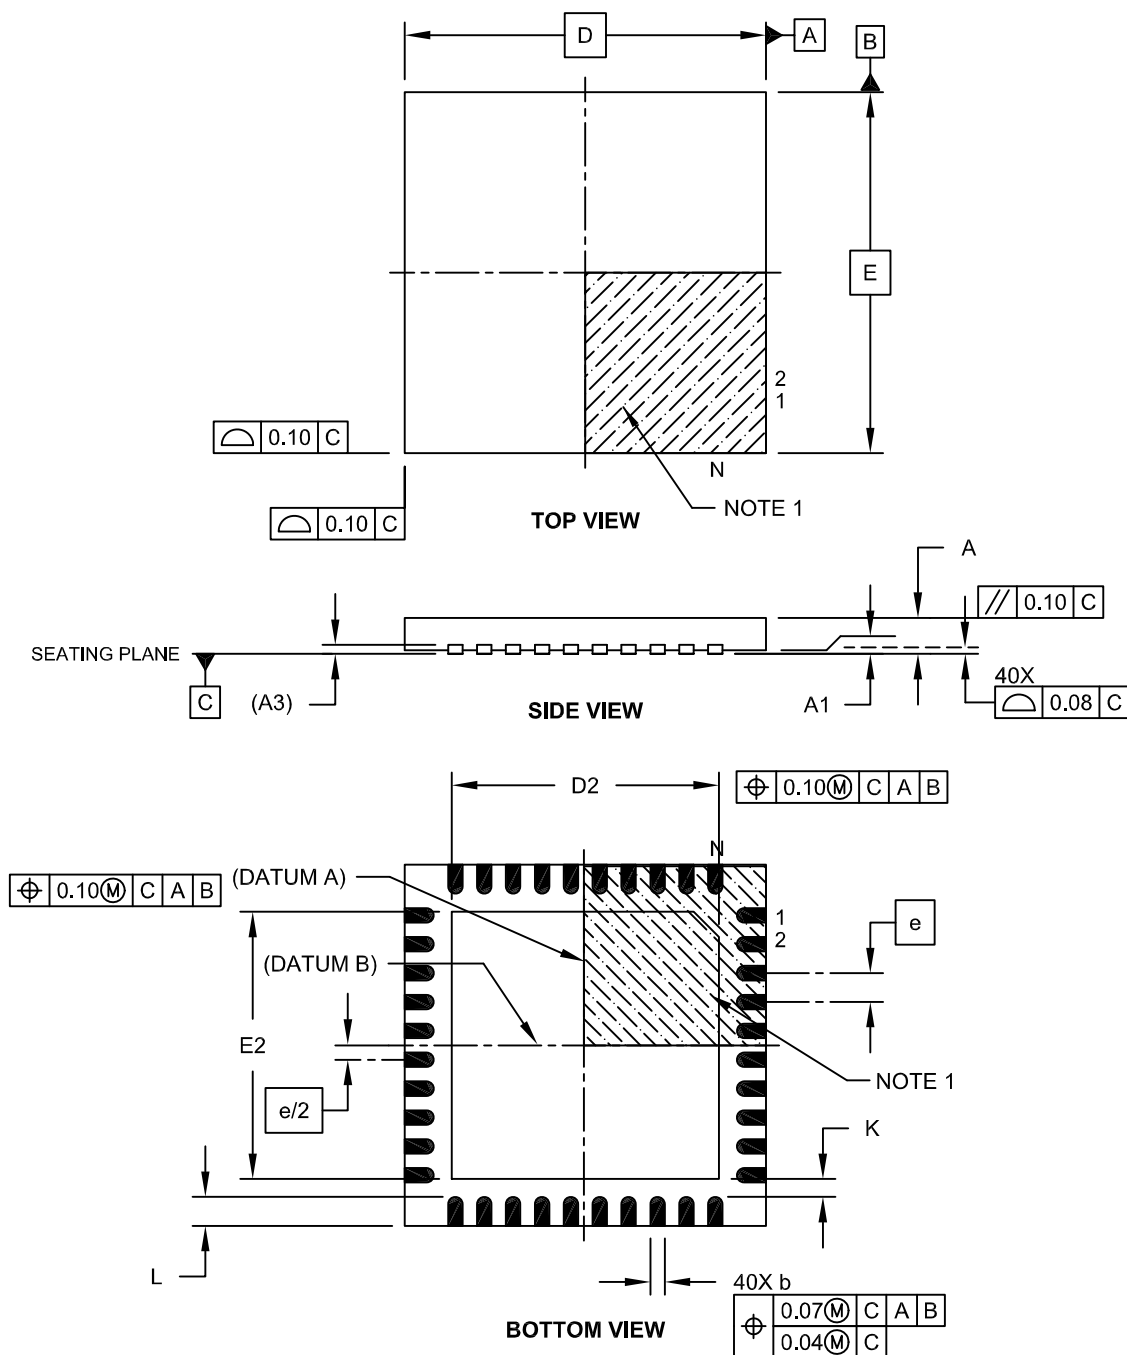
Microchip Technology Drawing C04-156A Sheet 1 of 2

### 40-Lead Ultra Thin Plastic Quad Flat, No Lead Package (MV) – 5x5x0.5 mm Body [UQFN]

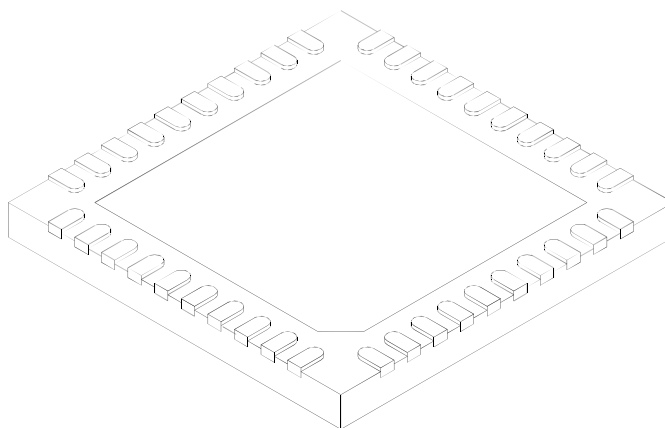
## 40-Lead Ultra Thin Plastic Quad Flat, No Lead Package (MV) – 5x5x0.5 mm Body [UQFN]
