# Product Change Notification - SYST-21VMFE730

**Notification subject:** ERRATA - PIC18F24K20/25K20/44K20/45K20 Silicon Data Sheet Errata Errata Document Revision

**Description of Change:** 1) Added reference to MPLAB X IDE. 2) Added Module 40, Low-Voltage Detect. 3) Data Sheet Clarifications: Added Module 2, Electrical Characteristics.

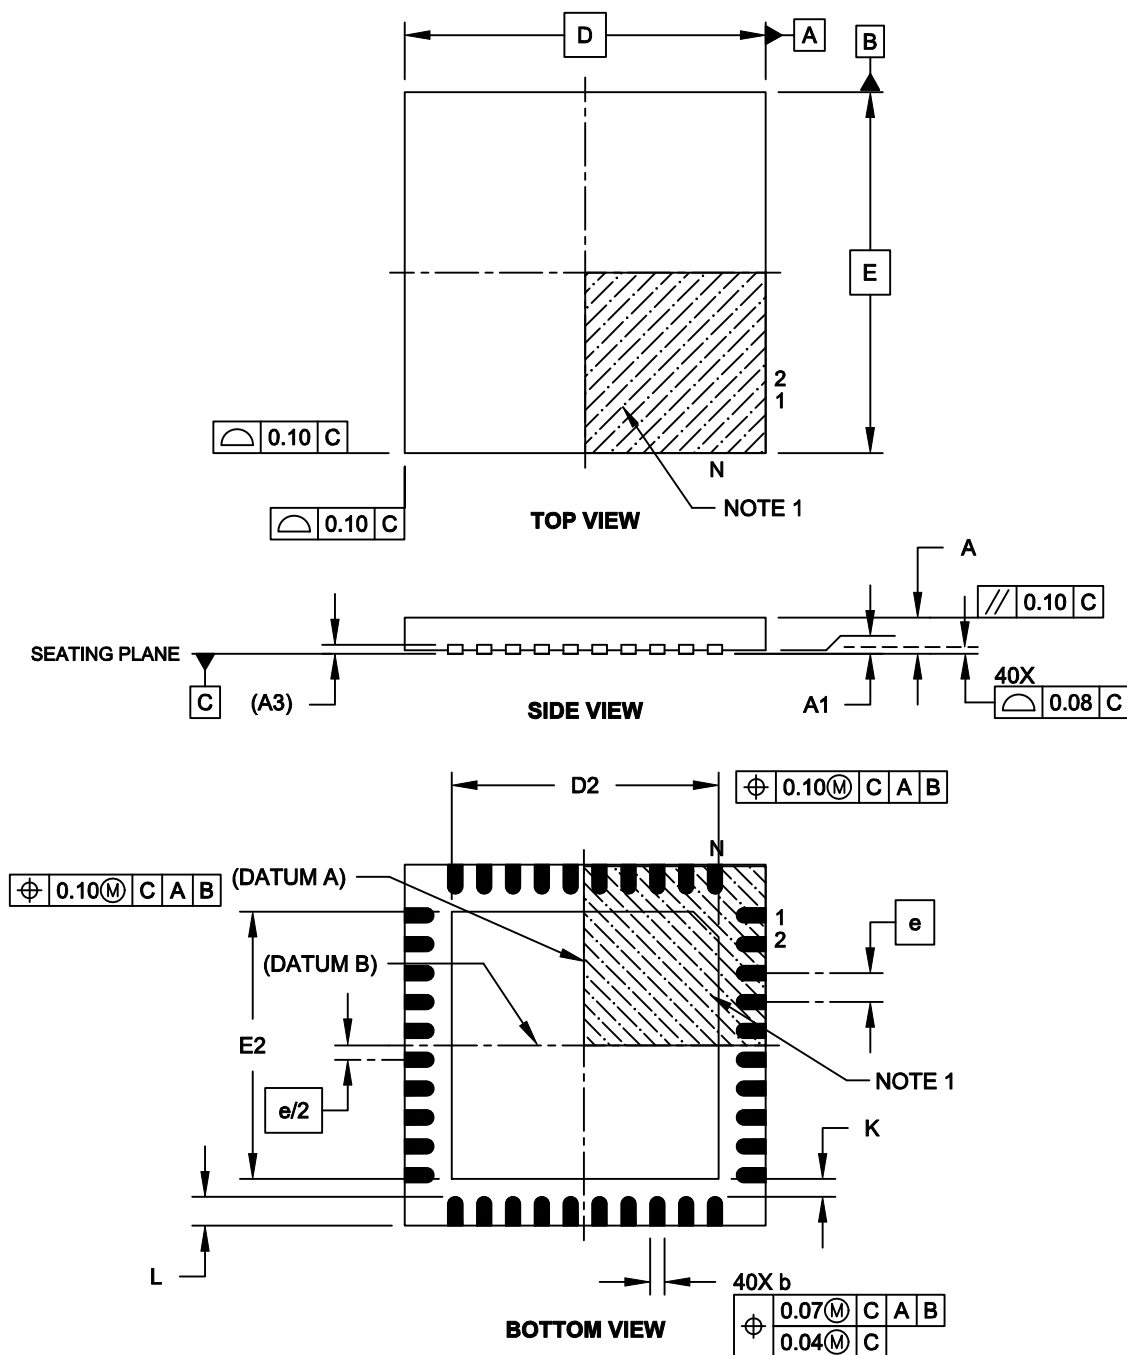
Microchip Technology Drawing C04-156A Sheet 1 of 2

### 40-Lead Ultra Thin Plastic Quad Flat, No Lead Package (MV) – 5x5x0.5 mm Body [UQFN]

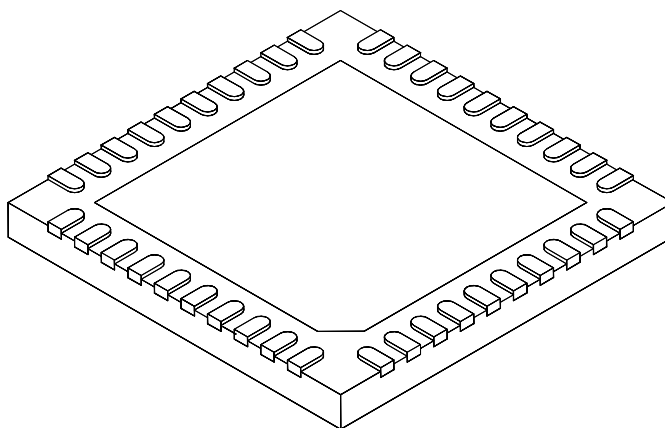
## 40-Lead Ultra Thin Plastic Quad Flat, No Lead Package (MV) – 5x5x0.5 mm Body [UQFN]
